## General Information

| Make | Nissan | Model | NV350 |
| YOM | 2019 | Odo Meter Reading | 93,842 |
| Registration No. | NEC3582 | Chassis No. | JNT1TC2E26Z0055941 |

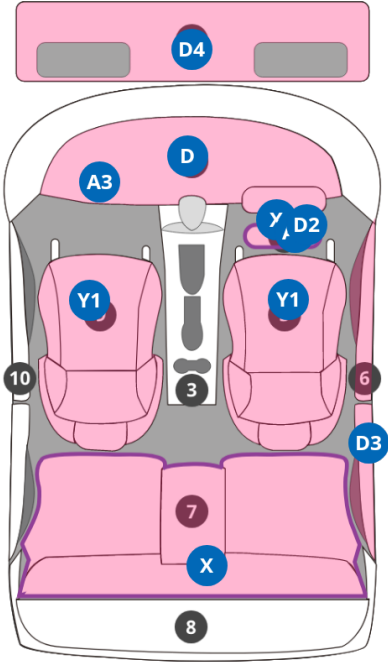
| Interior Evaluation : <span style="color: red;">C</span> | Exterior Evaluation : <span style="color: red;">E</span> |
| <b>Remarks</b><br>Rear Seat - Missing - Yes / Overall Interior - Worn as per age - Yes / (L) Front Floor Mat - Missing - Yes / Mat Other - Cut, Crack - Small / (R) Front Floor Mat - Worked - Small / Room Mirror - Missing - Yes / Dashboard - Traces of Adhesive Tape - Yes / (R) Rear Trim - Loose, Deformed - Medium / Ceiling - Crinkle - Large / Steering Wheel - Worn, Peel, Crack - Medium / (R) Front Seat - Grime - Minimal / (L) Front Seat - Grime - Minimal | <b>Remarks</b><br>(R) Front Door - Repair Traces - Yes / Front Panel - Repair Traces - Yes / (L) Front Door - Repair Traces - Yes / (L) Rear Fender - Repair Traces - Yes / Trunk Hood, Rear Gate - Repair Traces - Yes / (R) Rear Fender - Repair Traces - Yes / (R) Rear Door - Repair Traces - Yes / (R) Center Panel - Repair Traces - Yes / Roof - Repair Traces - Yes / Overall Exterior - Worn as per age - Yes / Overall Exterior - Full Re-Paint in same color - Yes / Overall Exterior - Re-Paint Uneven - Yes / Overall Exterior - Faded(Color, Gloss) - Yes / (R) Front Fender, Molding - Scratch & Dent - Small / (R) Mirror - Scratch - Small / (R) Front Door, Molding - Scratch & Dent - Medium / (R) Center Panel - Scratch - Small / (R) Rear Door, Molding - Scratch & Dent - Medium / (R) Rear Fender, Molding - Scratch - Small / Rear Bumper, Lamps, Panels - Repair mark - Yes / Front Bumper, Grille, Lamps - Repair mark - Yes / Rear Bumper, Lamps, Panels - Scratch - Small / Trunk Hood, Rear Gate - Scratch - Small / (L) Rear Fender, Molding - Scratch & Dent - Medium / (L) Rear Door, Molding - Scratch & Dent - Large / (L) Front Door, Molding - Scratch & Dent - Large / (L) Center Panel - Scratch & Dent - Medium / (L) Front Fender, Molding - Scratch & Dent - Small / (L) Mirror - Scratch - Small / Front Bumper, Grille, Lamps - Scratch - Small / Front Panel - Scratch & Dent - Small / Roof - Scratch & Dent - Large |
