## General Information

| Make | Mitsubishi | Model | Mirage |
| YOM | 2019 | Odo Meter Reading | 113,209 |
| Registration No. | NFU6292 | Chassis No. | PAEA13TXKKA009286 |

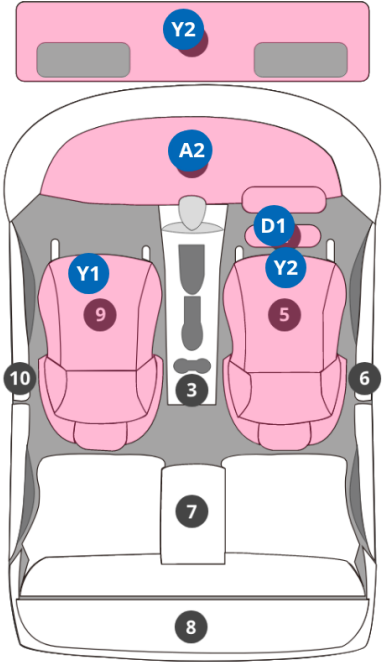
| Interior Evaluation : <b>B</b> | Exterior Evaluation : <b>E</b> |
| <p><b>Remarks</b></p> <p>Ceiling - Grime - Small / (R) Front Seat - Grime - Small / (L) Front Seat - Grime - Minimal / Dashboard - Traces of Adhesive Tape - Yes / Steering Wheel - Worn, Peel, Crack - Small / Carpet - Worked - Minimal</p> | <p><b>Remarks</b></p> <p>(R) Front Door - Repair Traces - Yes / (R) Front Fender - Repair Traces - Yes / Bonnet - Repair Traces - Yes / (L) Front Fender - Repair Traces - Yes / (L) Front Door - Repair Traces - Yes / (L) Rear Door - Repair Traces - Yes / (L) Rear Fender - Repair Traces - Yes / Trunk Hood, Rear Gate - Repair Traces - Yes / (R) Rear Fender - Repair Traces - Yes / (R) Rear Door - Repair Traces - Yes / Roof - Repair Traces - Yes / Overall Exterior - Full Re-Paint in same color - Yes / (R) Front Fender, Molding - Repair mark - Yes / (R) Front Fender, Molding - Scratch &amp; Dent - Medium / (R) Mirror - Scratch - Small / (R) Front Door, Molding - Scratch - Small / (R) Step, In-panel, Side Spoiler - Scratch &amp; Dent - Large / (R) Rear Door, Molding - Scratch - Medium / (R) Rear Fender, Molding - Scratch - Minimal / Roof - Scratch - Minimal / Rear Bumper, Lamps, Panels - Crack, Gap - Large / Trunk Hood, Rear Gate - Scratch - Minimal / (L) Rear Fender, Molding - Scratch &amp; Dent - Minimal / (L) Rear Door, Molding - Scratch &amp; Dent - Medium / (L) Front Door, Molding - Scratch &amp; Dent - Medium / (L) Mirror - Crack - Cracks / (L) Front Fender, Molding - Scratch - Small / Front Bumper, Grille, Lamps - Scratch &amp; Dent - Large / Bonnet, Headlight - Scratch - Large / (L) Step, In-panel, Side Spoiler - Scratch - Minimal / (L) Rear Tyre - Crack, Cut - Yes</p> |
