## General Information

| Make | Suzuki | Model | Ertiga |
| Registration No. | NNV2519 | Chassis No. | MHYNC32S8PJ103230 |

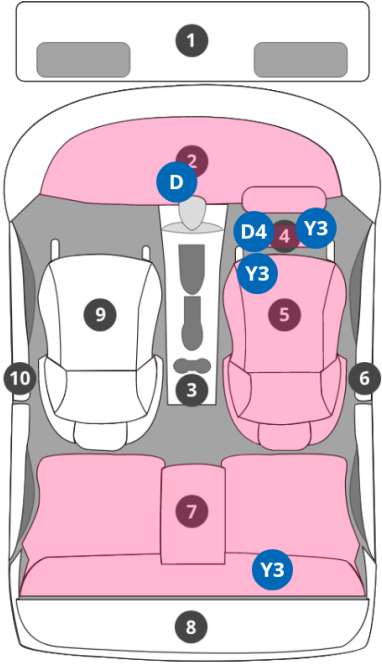
| Interior Evaluation : <span style="color: red; font-weight: bold;">C</span> | Exterior Evaluation : <span style="color: red; font-weight: bold;">E</span> |
| <b>Remarks</b><br>Rear Seat - Grime - Medium / (R) Front Seat - Grime - Medium / (R) Front Floor Mat - Grime - Medium / Dashboard - Traces of Adhesive Tape - Yes / (L) Front Floor Mat - Worked - Large | <b>Remarks</b><br>(L) Front Fender, Molding - Scratch - Medium / (L) Rear Fender, Molding - Scratch & Dent - Large / Rear Bumper, Lamps, Panels - Scratch & Dent - Medium / (L) Front Door, Molding - Scratch - Medium / (L) Rear Door, Molding - Scratch - Medium / (R) Rear Door, Molding - Scratch - Medium / (R) Front Door, Molding - Scratch - Medium / (R) Front Fender, Molding - Scratch - Small / Front Bumper, Grille, Lamps - Scratch - Small / Bonnet, Headlight - Scratch - Small / Trunk Hood, Rear Gate - Scratch - Small / (R) Rear Fender, Molding - Scratch - Small |
