## General Information

| Make | Hyundai | Model | Stargazer |
| Registration No. | NKJ5339 | Chassis No. | MF3NB81DERJ060177 |

## Body / Panel Condition

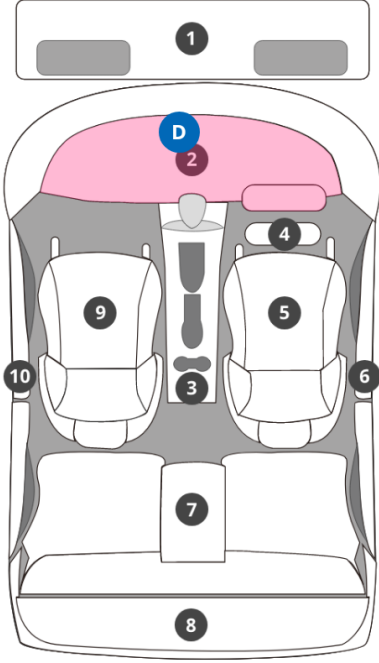
| Interior Evaluation : <span style="color: red; font-weight: bold;">A</span> | Exterior Evaluation : <span style="color: red; font-weight: bold;">D</span> |
|---|---|
| <b>Remarks</b><br>Dashboard - Traces of Adhesive Tape - Yes | <b>Remarks</b><br>(R) Front Door, Molding - Scratch - Large / (R) Front Fender, Molding - Scratch - Large / (R) Rear Door, Molding - Scratch & Dent - Large / Rear Bumper, Lamps, Panels - Scratch - Small / Trunk Hood, Rear Gate - Scratch - Medium / Bonnet, Headlight - Scratch - Large / (R) Rear Fender, Molding - Scratch & Dent - Small / (L) Rear Fender, Molding - Dent - Small |
