## General Information

| Make | Mitsubishi | Model | L300 |
| Registration No. | NKP1930 | Chassis No. | PAEL65NYSSB002749 |

## Body / Panel Condition

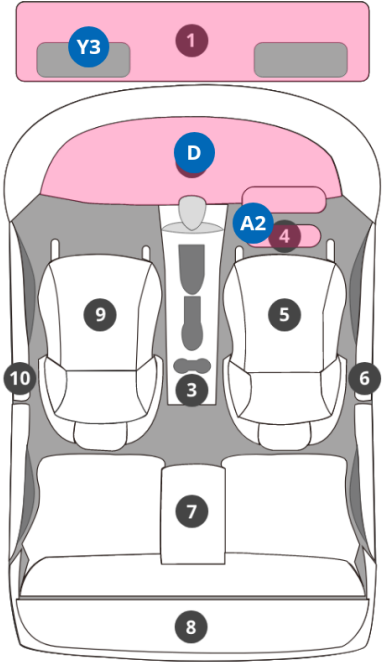
| Interior Evaluation : <b>B</b> | Exterior Evaluation : <b>E</b> |
| <p><b>Remarks</b><br/>Carpet - Worn, Scratch, Cut, Crack - Small / Dashboard - Traces of Adhesive Tape - Yes / Sunvisor, Sunglass Holder - Grime - Medium</p> | <p><b>Remarks</b><br/>(L) Step, In-panel, Side Spoiler - Scratch - Minimal / (L) Front Door, Molding - Scratch - Minimal / (L) Side Gate - Scratch - Medium / Rear Gate - Scratch &amp; Dent - Medium / (R) Side Gate - Scratch - Large / (R) Step, In-panel, Side Spoiler - Scratch - Small / (R) Front Door, Molding - Scratch &amp; Dent - Medium / (R) Front Fender, Molding - Scratch &amp; Dent - Medium / Front Bumper, Grille, Lamps - Scratch &amp; Dent - Medium / Roof - Scratch - Small / Rear Bumper, Lamps, Panels - Rust, Corrosion - Large / Cargo Bed Floor - Scratch - Large</p> |
