## General Information

| Make | Toyota | Model | Innova |
| Registration No. | DAG1131 | Chassis No. | PA2GA8EM4H0032886 |

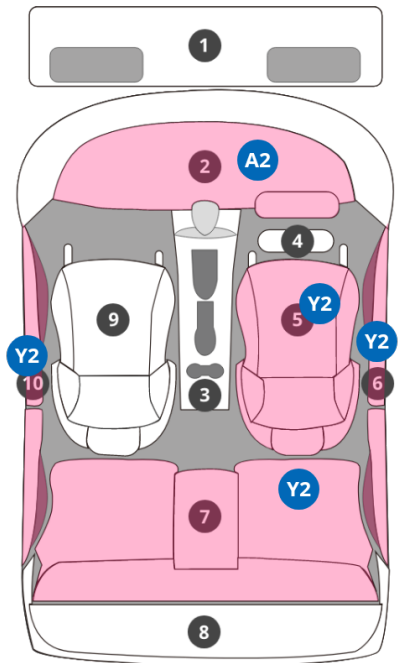
| Interior Evaluation : <b>B</b> | Exterior Evaluation : <b>C</b> |
|---|---|
| <b>Remarks</b><br>(R) Front Trim - Grime - Small / (L) Front Trim - Grime - Small / (R) Front Seat - Grime - Small / Dashboard - Worn, Scratch, Cut, Crack - Small / Rear Seat - Grime - Small | <b>Remarks</b><br>(R) Front Door - Repair Traces - Yes / (R) Step - Replaced - Yes / (R) Step - Repair Traces - Yes / (R) Front Fender - Repair Traces - Yes / Bonnet - Repair Traces - Yes / (L) Front Fender - Repair Traces - Yes / (L) Front Door - Repair Traces - Yes / (L) Step - Replaced - Yes / (L) Rear Door - Repair Traces - Yes / (L) Rear Fender - Repair Traces - Yes / Trunk Hood, Rear Gate - Repair Traces - Yes / (R) Rear Fender - Repair Traces - Yes / (R) Rear Door - Repair Traces - Yes / Roof - Repair Traces - Yes / Trunk Hood, Rear Gate - Rust, Corrosion - Large / (L) Rear Fender, Molding - Crack, Gap - Small / (L) Front Door, Molding - Scratch - Small / Front Bumper, Grille, Lamps - Scratch - Medium / Bonnet, Headlight - Scratch & Dent - Medium / (R) Front Fender, Molding - Crack, Gap - Small / (R) Front Door, Molding - Scratch - Small |
