## General Information

| Make | Hyundai | Model | Accent |
| YOM | 2016 | Odo Meter Reading | 76,216 |
| Registration No. | NDD3964 | Chassis No. | KMHCT41BEHU190234 |

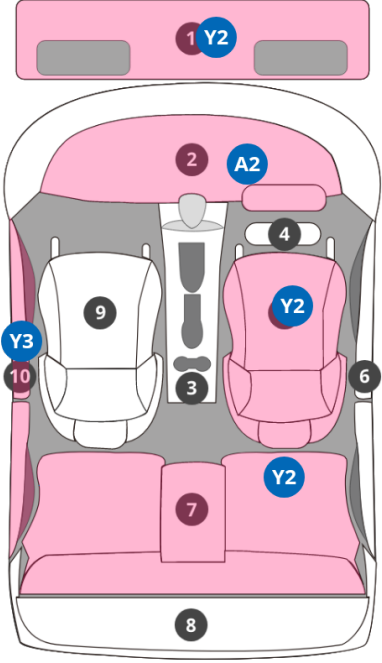
| Interior Evaluation : <b>B</b> | Exterior Evaluation : <b>C</b> |
|---|---|
| <p><b>Remarks</b></p> <p>(L) Front Trim - Grime - Medium / (R) Front Seat - Grime - Small / Dashboard - Worn, Scratch, Cut, Crack - Small / Ceiling - Grime - Small / Rear Seat - Grime - Small</p> | <p><b>Remarks</b></p> <p>(R) Front Door - Repair Traces - Yes / (R) Step - Replaced - Yes / (R) Step - Repair Traces - Yes / (R) Front Fender - Repair Traces - Yes / Bonnet - Repair Traces - Yes / (L) Front Fender - Repair Traces - Yes / (L) Front Door - Repair Traces - Yes / (L) Step - Repair Traces - Yes / (L) Rear Door - Repair Traces - Yes / (L) Rear Fender - Repair Traces - Yes / Trunk Hood, Rear Gate - Repair Traces - Yes / Rear End Panel - Repair Traces - Yes / (R) Rear Fender - Repair Traces - Yes / (R) Rear Door - Repair Traces - Yes / Roof - Repair Traces - Yes / (R) Front Fender, Molding - Crack, Gap - Medium / Front Bumper, Grille, Lamps - Scratch - Medium / (L) Front Fender, Molding - Scratch - Medium / (L) Rear Door, Molding - Repair mark - Yes / (L) Front Door, Molding - Scratch - Small / (L) Rear Fender, Molding - Scratch &amp; Dent - Medium / Trunk Hood, Rear Gate - Scratch - Small / Rear Bumper, Lamps, Panels - Crack, Gap - Small / (R) Front Door, Molding - Scratch - Small / (R) Mirror - Scratch, Peeled - Minimal</p> |
