## General Information

| Make | Suzuki | Model | XL7 |
| Registration No. | GBJ6600 | Chassis No. | MHYNC32S7TJ100023 |

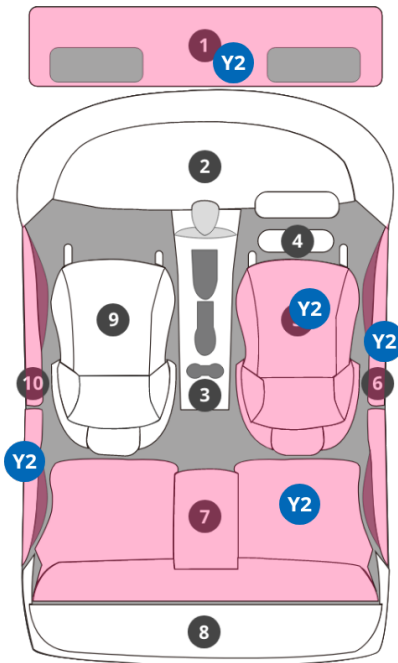
| Interior Evaluation : <b>B</b> | Exterior Evaluation : <b>C</b> |
|---|---|
| <b>Remarks</b><br>Rear Seat - Grime - Small / (R) Front Trim - Grime - Small / (R) Front Seat - Grime - Small / Ceiling - Grime - Small / (L) Rear Trim - Grime - Small | <b>Remarks</b><br>(L) Front Door, Molding - Scratch & Dent - Large / (L) Rear Door, Molding - Scratch - Small / (L) Rear Fender, Molding - Scratch - Medium / Front Bumper, Grille, Lamps - Scratch - Small / (R) Front Door, Molding - Dent - Minimal |

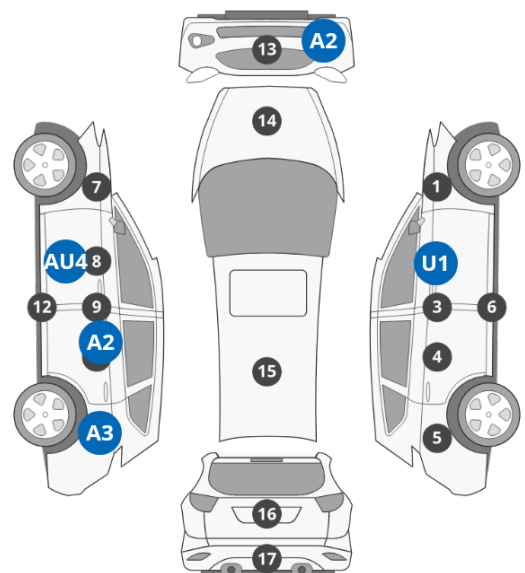
visible hairline scratches on left rear door. With Spare tire. With Spare key. No warranty booklet. No Seat cover.
