## General Information

| Make | Toyota | Model | Vios |
| Registration No. | DAR4112 | Chassis No. | PA1B18F38N4183038 |

## Overall Evaluation :

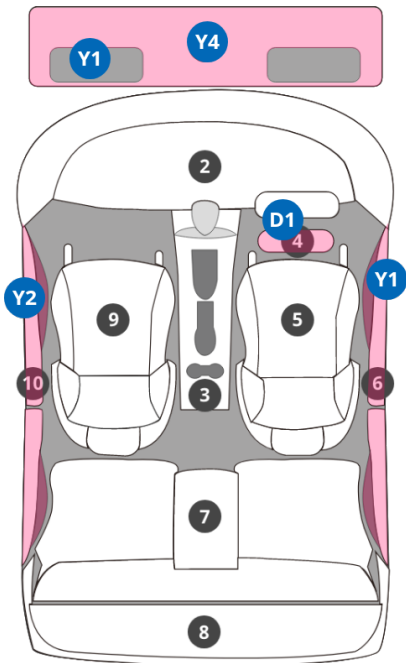
| Interior Evaluation : <span style="color: red;">C</span> | Exterior Evaluation : <span style="color: red;">D</span> |
|---|---|
| <p><b>Remarks</b></p> <p>Ceiling - Grime - Large / (R) Front Trim - Grime - Minimal / Carpet - Worked - Minimal / (L) Front Trim - Grime - Small / Sunvisor, Sunglass Holder - Grime - Minimal</p> | <p><b>Remarks</b></p> <p>(R) Front Door - Repair Traces - Yes / (R) Step - Repair Traces - Yes / (R) Front Fender - Repair Traces - Yes / Bonnet - Repair Traces - Yes / (L) Front Fender - Repair Traces - Yes / (L) Front Door - Repair Traces - Yes / (L) Rear Door - Repair Traces - Yes / (L) Rear Fender - Repair Traces - Yes / Trunk Hood, Rear Gate - Repair Traces - Yes / (R) Rear Fender - Repair Traces - Yes / (R) Rear Door - Repair Traces - Yes / Roof - Repair Traces - Yes / Overall Exterior - Full Re-Paint in same color - Yes / (R) Front Fender, Molding - Repair mark - Yes / (R) Front Fender, Molding - Scratch &amp; Dent - Minimal / (R) Front Door, Molding - Repair mark - Yes / (R) Front Door, Molding - Scratch - Minimal / (R) Rear Door, Molding - Scratch &amp; Dent - Medium / Roof - Scratch - Minimal / (R) Rear Fender, Molding - Scratch - Minimal / Trunk Hood, Rear Gate - Scratch &amp; Dent - Minimal / Rear Bumper, Lamps, Panels - Scratch &amp; Dent - Small / (L) Rear Fender, Molding - Scratch - Minimal / (L) Rear Door, Molding - Scratch - Small / (L) Front Door, Molding - Repair mark - Yes / (L) Front Door, Molding - Scratch - Minimal / (L) Mirror - Scratch - Minimal / (L) Front Fender, Molding - Repair mark - Yes / (L) Front Fender, Molding - Scratch - Minimal / Front Bumper, Grille, Lamps - Crack, Gap - Medium / Bonnet, Headlight - Repair mark - Yes / Bonnet, Headlight - Scratch - Minimal / (L) Step, In-panel, Side Spoiler - Scratch - Minimal / Roof Spoiler, Molding - Scratch - Minimal / (R) Mirror - Scratch - Minimal</p> |
