## General Information

| Make | Hyundai | Model | Accent |
| YOM | 2014 | Odo Meter Reading | 123,670 |
| Registration No. | AAF4567 | Chassis No. | KMHCT51UBEU149901 |

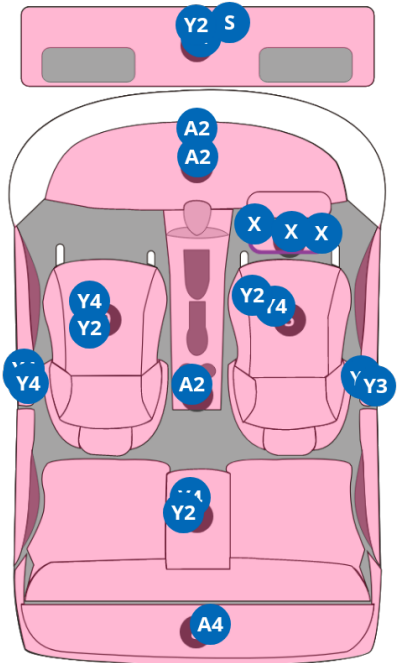
| Interior Evaluation : <b>E</b> | Exterior Evaluation : <b>E</b> |
| <p><b>Remarks</b></p> <p>Overall Interior - Worn as per age - Yes / Overall Interior - Animal Hair - Yes / Overall Interior - Smell - Yes / Dashboard - Worn, Scratch, Cut, Crack - Small / Glove Box - Worn, Scratch, Cut, Crack - Small / (L) Front Seat - Grime - Large / (L) Front Seat belt - Grime - Small / (L) Front Trim - Grime - Medium / Trim Other - Grime - Large / (L) Rear Trim - Grime - Large / Knobs - Worn, Peel, Crack - Small / (R) Front Seat - Grime - Large / (R) Front Seat belt - Grime - Small / (R) Front Trim - Grime - Medium / (R) Rear Trim - Grime - Large / Trim Other - Grime - Medium / Rear Seat - Grime - Large / Ceiling - Grime - Small / Seat belt Other - Grime - Small / Trunk Room - Worn, Scratch, Cut, Crack - Large / (R) Front Floor Mat - Missing - Yes / (L) Front Floor Mat - Missing - Yes / Mat Other - Missing - Yes</p> | <p><b>Remarks</b></p> <p>(R) Front Door - Repair Traces - Yes / (R) Front Fender - Repair Traces - Yes / Bonnet - Repair Traces - Yes / (L) Front Fender - Repair Traces - Yes / (L) Front Door - Repair Traces - Yes / (L) Rear Door - Repair Traces - Yes / (L) Rear Fender - Repair Traces - Yes / Trunk Hood, Rear Gate - Repair Traces - Yes / (R) Rear Fender - Repair Traces - Yes / (R) Rear Door - Repair Traces - Yes / Roof - Repair Traces - Yes / Overall Exterior - Worn as per age - Yes / Overall Exterior - Full Re-Paint in same color - Yes / Front Bumper, Grille, Lamps - Scratch - Medium / Bonnet, Headlight - Scratch - Small / (R) Front Fender, Molding - Rust, Corrosion - Medium / (R) Front Door, Molding - Scratch - Medium / (R) Rear Door, Molding - Rust, Corrosion - Medium / (R) Mirror - Scratch - Small / (R) Step, In-panel, Side Spoiler - Scratch &amp; Dent - Small / (R) Side Window - Scratch, Stone chip - Small / (R) Rear Fender, Molding - Scratch - Small / Trunk Hood, Rear Gate - Scratch - Small / Rear Bumper, Lamps, Panels - Scratch - Medium / (L) Rear Fender, Molding - Scratch - Small / (L) Rear Door, Molding - Rust, Corrosion - Large / (L) Step, In-panel, Side Spoiler - Scratch - Small / (L) Side Window - Scratch, Stone chip - Small / (L) Mirror - Scratch, Peeled - Minimal / (L) Front Door, Molding - Rust, Corrosion - Small / (L) Front Fender, Molding - Crack, Gap - Small / Front Windshield - Scratch, Stone chip - Small</p> |
