## General Information

| Make | Toyota | Model | Innova |
| Registration No. | DBR1847 | Chassis No. | PA2JA8EM8R0150849 |

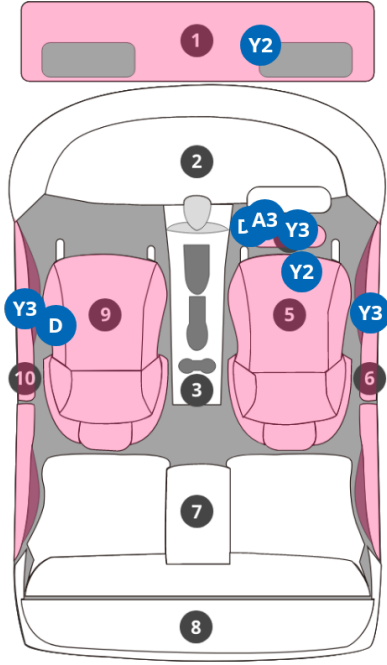
| <b>Interior Evaluation :</b> <span style="color: red; font-weight: bold;">C</span> | <b>Exterior Evaluation :</b> <span style="color: red; font-weight: bold;">D</span> |
| <b>Remarks</b><br>(L) Front Seat - Worn - Yes / (R) Front Seat - Grime - Small / (L) Front Trim - Grime - Medium / (R) Front Trim - Grime - Medium / (L) Front Floor Mat - Worked - Large / (L) Front Floor Mat - Cut, Crack - Medium / Mat Other - Grime - Medium / Ceiling - Grime - Small | <b>Remarks</b><br>Trunk Hood, Rear Gate - Repair Traces - Yes / (R) Rear Door - Repair Traces - Yes / (R) Front Fender, Molding - Scratch - Minimal / (R) Mirror - Scratch - Minimal / (R) Front Door, Molding - Scratch - Small / (R) Rear Door, Molding - Scratch - Small / (R) Rear Fender, Molding - Scratch - Minimal / Rear Bumper, Lamps, Panels - Scratch - Small / Trunk Hood, Rear Gate - Dent - Large / (L) Rear Fender, Molding - Scratch - Small / (L) Front Door, Molding - Scratch - Large / (L) Rear Door, Molding - Scratch - Medium / (L) Mirror - Scratch - Minimal / (L) Front Fender, Molding - Scratch - Small / Front Bumper, Grille, Lamps - Scratch - Small / Bonnet, Headlight - Scratch - Minimal / Roof - Scratch - Minimal |

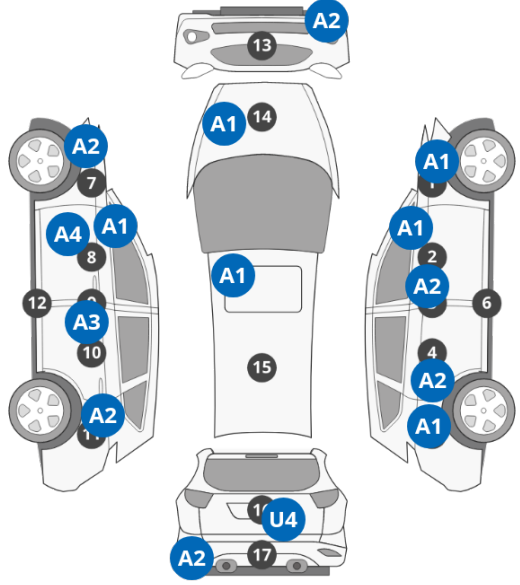
| Inspector Notes |
|---|
| no warranty booklet, with jack and tools, with spare tire, with LTO plate, scratches on tail light, brake light issue |
