## General Information

| Make | Toyota | Model | Vios |
| YOM | 2026 | Odo Meter Reading | 3,868 |
| Registration No. | CDA7256 | Chassis No. | PA1B18F30S4297535 |

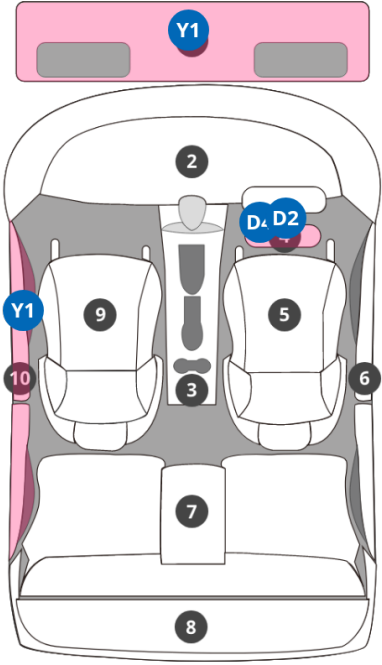
| Interior Evaluation : <span style="color: red;">C</span> | Exterior Evaluation : <span style="color: red;">D</span> |
|---|---|
| <b>Remarks</b><br>Ceiling - Grime - Minimal / Carpet - Worked - Large / (L) Front Trim - Grime - Minimal / (L) Front Floor Mat - Worked - Small | <b>Remarks</b><br>(R) Front Fender, Molding - Scratch - Small / (R) Mirror - Scratch - Minimal / (R) Front Door, Molding - Scratch - Medium / (R) Rear Door, Molding - Scratch - Medium / (R) Rear Fender, Molding - Scratch & Dent - Minimal / Rear Bumper, Lamps, Panels - Scratch - Minimal / Trunk Hood, Rear Gate - Scratch - Minimal / (L) Rear Fender, Molding - Dent - Minimal / (L) Rear Door, Molding - Scratch - Minimal / (L) Step, In-panel, Side Spoiler - Scratch - Minimal / (L) Front Door, Molding - Scratch - Minimal / (L) Front Fender, Molding - Scratch & Dent - Large / Front Bumper, Grille, Lamps - Crack, Gap - Large / Bonnet, Headlight - Scratch & Dent - Large |

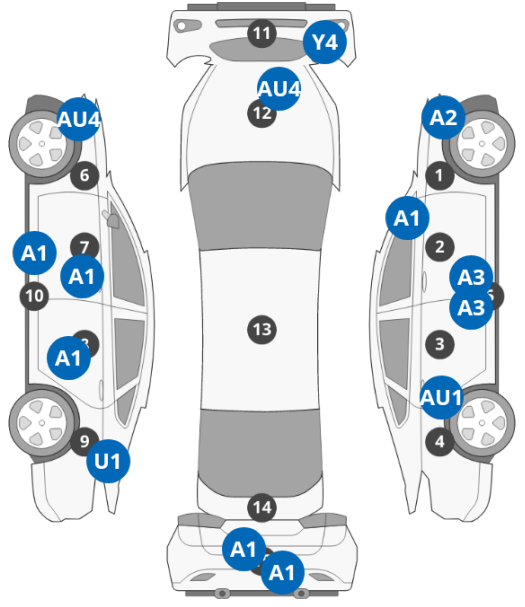
With Lto plate, with warranty booklet, 3keys, no spare tire, no jack and tools, scratches on taillights, crack headlight, battery weak, bumper logo and hook cover missing ,L front fender issue
