## General Information

| Make | Nissan | Model | Almera |
| Registration No. | NAB8426 | Chassis No. | BDUALBAH17B50475 |

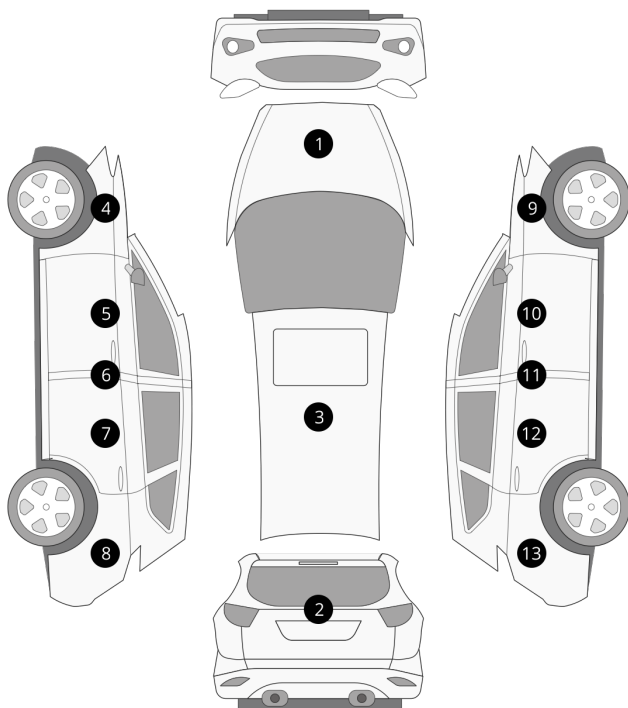
## Body / Panel Condition

| # | Area | Thickness(um) | | | |
|---|---|---|---|---|---|
| 1 | Bonnet | 187.3 | 203 | 186 | 173 |
| 2 | Boot Lid | 100.8 | 106 | 85 | 111 |
| 3 | Roof | 103.5 | 117 | 100 | 106/91 |
| 4 | Left Front Fender | 233.3 | 228 | 207 | 265 |
| 5 | Left Front Door | 154.3 | 154 | 154 | 155 |
| 7 | Left Rear Door | 69.8 | 69 | 65 | 76 |
| 8 | Left Back Panel | 271.3 | 161 | 173 | 480 |
| 9 | Right Front Fender | 395.0 | 280 | 259 | 646 |
| 10 | Right Front Door | 101.3 | 101 | 101 | 102 |
| 12 | Right Rear Door | 105.6 | 103 | 100 | 114 |
| 13 | Right Back Panel | 115.0 | 125 | 109 | 111 |

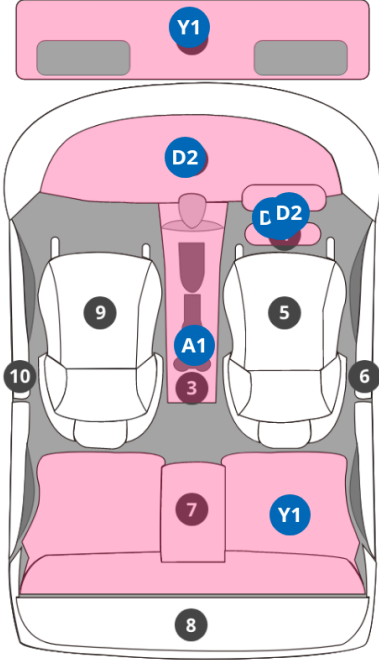
| Interior Evaluation : <span style="color: red;">C</span> | Exterior Evaluation : <span style="color: red;">E</span> |
|---|---|
| <p><b>Remarks</b></p> <p>Ceiling - Grime - Minimal / Console, Switchs, Vents - Worn, Scratch, Cut, Crack - Minimal / Dashboard - Loose, Deformed - Small / Carpet - Worked - Minimal / (L) Front Floor Mat - Worked - Large / Rear Seat - Grime - Minimal / (R) Front Floor Mat - Worked - Small</p> | <p><b>Remarks</b></p> <p>(R) Front Door - Repair Traces - Yes / (R) Front Fender - Repair Traces - Yes / Bonnet - Repair Traces - Yes / (L) Front Fender - Repair Traces - Yes / (L) Rear Door - Repair Traces - Yes / (L) Rear Fender - Repair Traces - Yes / Trunk Hood, Rear Gate - Repair Traces - Yes / (R) Rear Door - Repair Traces - Yes / Roof - Repair Traces - Yes / Overall Exterior - Full Re-Paint in same color - Yes / (R) Front Fender, Molding - Scratch - Minimal / Overall Exterior - Faded(Color, Gloss) - Yes / (R) Front Door, Molding - Scratch &amp; Dent - Minimal / (R) Rear Door, Molding - Scratch &amp; Dent - Small / (R) Step, In-panel, Side Spoiler - Scratch - Medium / (R) Rear Fender, Molding - Scratch - Large / Trunk Hood, Rear Gate - Scratch &amp; Dent - Medium / Rear Bumper, Lamps, Panels - Crack, Gap - Large / (L) Rear Door, Molding - Scratch - Large / (L) Step, In-panel, Side Spoiler - Scratch - Large / (L) Front Door, Molding - Scratch - Large / (L) Mirror - Scratch - Minimal / Roof Spoiler, Molding - Scratch &amp; Dent - Small / (L) Rear Fender, Molding - Scratch &amp; Dent - Small / (L) Front Fender, Molding - Scratch - Medium / Front Bumper, Grille, Lamps - Scratch - Large / Bonnet, Headlight - Scratch - Large / Roof - Scratch &amp; Dent - Minimal</p> |

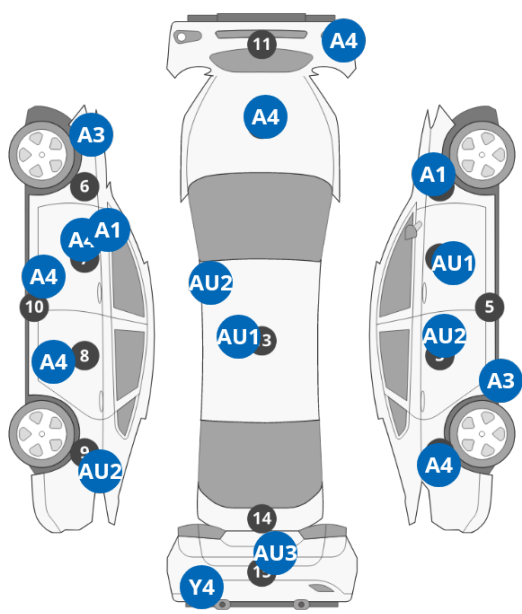
| Inspector Notes |
|---|
| With Lto plate, with spare tire and jack, 1key, no warranty booklet and tools, scratches on headlights, Crack taillight, plate light issue, aircon issue, check engine warning lamp on |
