## General Information

| Make | Toyota | Model | Vios |
| Registration No. | NIH2669 | Chassis No. | PA1B18F38N4199292 |

## Body / Panel Condition

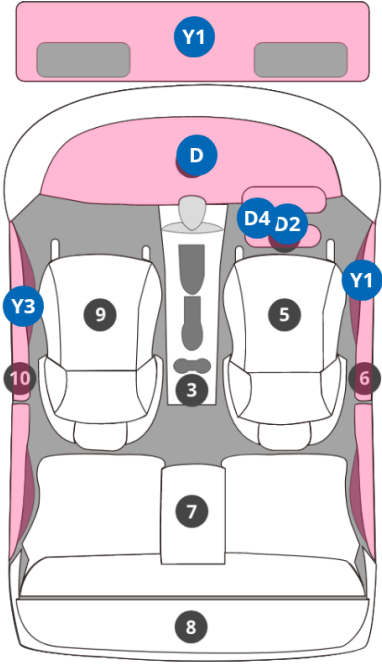
| Interior Evaluation : <b>C</b> | Exterior Evaluation : <b>E</b> |
|---|---|
| <p><b>Remarks</b></p> <p>Ceiling - Grime - Minimal / (L) Front Trim - Grime - Medium / (L) Front Floor Mat - Worked - Small / Carpet - Worked - Large / Dashboard - Traces of Adhesive Tape - Yes / (R) Front Trim - Grime - Minimal</p> | <p><b>Remarks</b></p> <p>(R) Front Door - Repair Traces - Yes / (R) Front Fender - Repair Traces - Yes / Bonnet - Repair Traces - Yes / (L) Front Door - Repair Traces - Yes / (L) Rear Door - Repair Traces - Yes / (R) Rear Fender - Repair Traces - Yes / (R) Rear Door - Repair Traces - Yes / Roof - Repair Traces - Yes / Overall Exterior - Full Re-Paint in same color - Yes / (R) Front Fender, Molding - Scratch - Small / (R) Mirror - Scratch - Minimal / (R) Front Door, Molding - Scratch &amp; Dent - Small / (R) Rear Door, Molding - Repair mark - Yes / (R) Rear Door, Molding - Scratch - Small / (R) Step, In-panel, Side Spoiler - Scratch &amp; Dent - Medium / (R) Rear Fender, Molding - Scratch - Minimal / Rear Bumper, Lamps, Panels - Scratch - Large / Trunk Hood, Rear Gate - Scratch &amp; Dent - Medium / (L) Rear Fender, Molding - Scratch &amp; Dent - Small / (L) Rear Door, Molding - Scratch &amp; Dent - Large / (L) Front Door, Molding - Repair mark - Yes / (L) Front Door, Molding - Scratch &amp; Dent - Small / (L) Step, In-panel, Side Spoiler - Scratch - Minimal / (L) Mirror - Scratch - Minimal / (L) Front Fender, Molding - Scratch - Minimal / Front Bumper, Grille, Lamps - Crack, Gap - Medium / Bonnet, Headlight - Scratch &amp; Dent - Small / Roof - Dent - Minimal</p> |

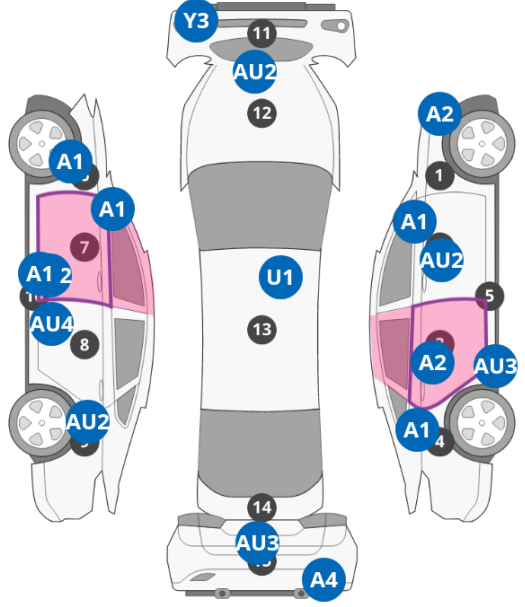
With Lto plate, with spare tire, with jack and tools, 3keys, no warranty booklet, scratches on headlights, Crack taillight, Worn out tires
