## General Information

| Make | Toyota | Model | Vios |
| Registration No. | EAD9036 | Chassis No. | PA1B18F37L4114326 |

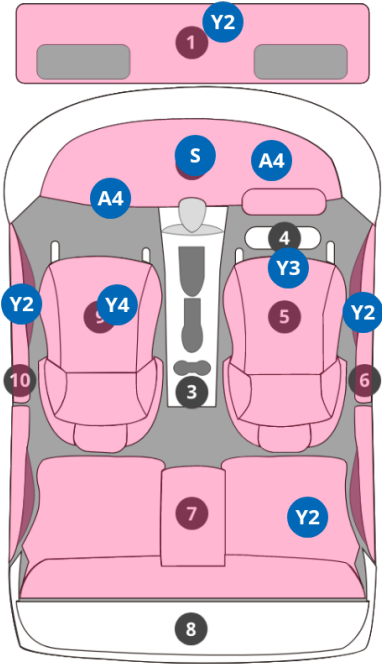
| <b>Interior Evaluation :</b> <span style="color: red; font-weight: bold;">C</span> | <b>Exterior Evaluation :</b> <span style="color: red; font-weight: bold;">N / A</span> |
| <b>Remarks</b><br>Steering Wheel - Worn, Peel, Crack - Large / Dashboard - Worn, Scratch, Cut, Crack - Large / (L) Front Seat - Grime - Large / (R) Front Seat - Grime - Medium / Ceiling - Grime - Small / Rear Seat - Grime - Small / (L) Front Trim - Grime - Small / (R) Front Trim - Grime - Small / Overall Interior - Worn as per age - Yes / Overall Interior - Smell - Yes | <b>Remarks</b><br>Defects not found |
