## General Information

| Make | Toyota | Model | Vios |
| Registration No. | CBL1404 | Chassis No. | PA1B18F38L4128414 |

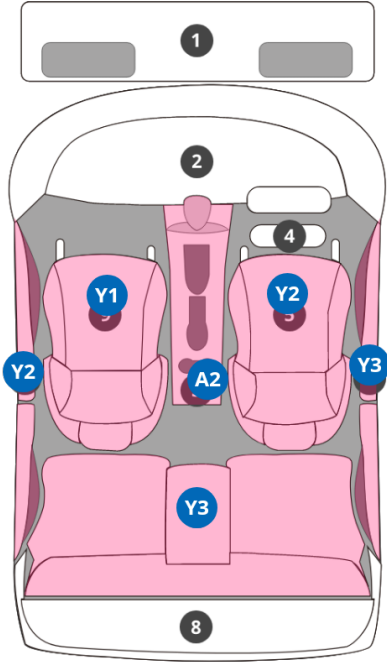
| Interior Evaluation : <b>B</b> | Exterior Evaluation : <b>E</b> |
|---|---|
| <b>Remarks</b><br>(L) Front Trim - Grime - Small / (R) Front Trim - Grime - Medium / Knobs - Worn, Peel, Crack - Small / (R) Front Seat - Grime - Small / (L) Front Seat - Grime - Minimal / Rear Seat - Grime - Medium | <b>Remarks</b><br>(R) Front Door - Repair Traces - Yes / (R) Step - Repair Traces - Yes / (R) Step - Replaced - Yes / (R) Front Fender - Repair Traces - Yes / Bonnet - Repair Traces - Yes / (L) Front Fender - Repair Traces - Yes / (L) Front Door - Repair Traces - Yes / (L) Step - Repair Traces - Yes / (L) Rear Door - Repair Traces - Yes / (L) Rear Fender - Repair Traces - Yes / Trunk Hood, Rear Gate - Repair Traces - Yes / (R) Rear Fender - Repair Traces - Yes / (R) Rear Fender - Replaced - Yes / (R) Rear Door - Repair Traces - Yes / Roof - Repair Traces - Yes / Overall Exterior - Color Change - Yes / (R) Front Fender, Molding - Scratch - Small / (R) Front Door, Molding - Scratch - Medium / (R) Step, In-panel, Side Spoiler - Scratch & Dent - Medium / (R) Rear Door, Molding - Scratch - Small / (R) Rear Fender, Molding - Scratch - Small / (L) Front Fender, Molding - Scratch - Small / (L) Front Door, Molding - Scratch - Medium / (L) Step, In-panel, Side Spoiler - Scratch - Small / (L) Rear Door, Molding - Scratch - Medium / (L) Rear Fender, Molding - Repair mark - Difference in Color / Rear Bumper, Lamps, Panels - Crack, Gap - Medium / Trunk Hood, Rear Gate - Scratch - Medium / Roof - Repair mark - Difference in Color / Bonnet, Headlight - Scratch - Small / Front Bumper, Grille, Lamps - Crack, Gap - Medium |
