## General Information

| Make | Mitsubishi | Model | L300 |
| Registration No. | FAQ3736 | Chassis No. | PAEL65MYRPB010002 |

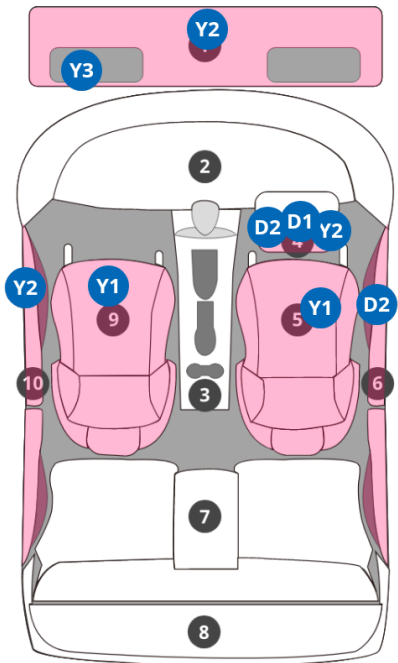
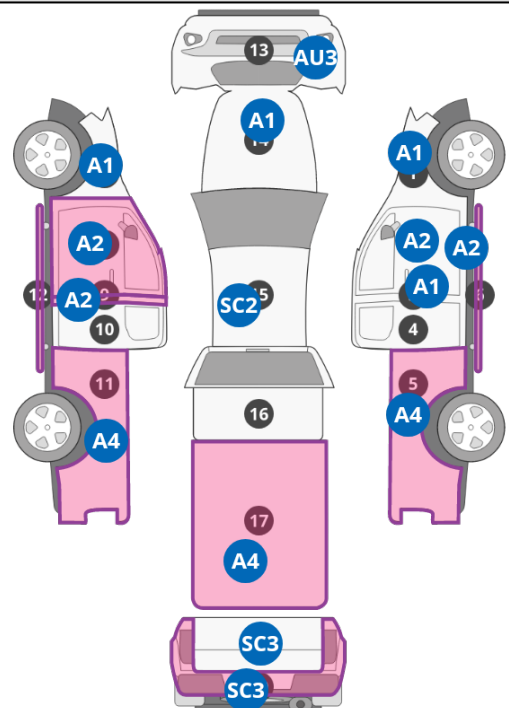
| Interior Evaluation : <b>B</b> | Exterior Evaluation : <b>E</b> |
| <p><b>Remarks</b></p> <p>(R) Front Trim - Loose, Deformed - Small / (R) Front Floor Mat - Grime - Small / Carpet - Worked - Minimal / (L) Front Trim - Grime - Small / (L) Front Floor Mat - Worked - Small / Sunvisor, Sunglass Holder - Grime - Medium / Ceiling - Grime - Small / (L) Front Seat - Grime - Minimal / (R) Front Seat - Grime - Minimal</p> | <p><b>Remarks</b></p> <p>Cargo Bed Floor - Scratch - Large / Rear Bumper, Lamps, Panels - Rust, Corrosion - Medium / (R) Side Gate - Repair mark - Yes / Rear Bumper, Lamps, Panels - Repair mark - Yes / (L) Side Gate - Repair mark - Yes / Cargo Bed Floor - Repair mark - Yes / (R) Front Fender, Molding - Scratch - Minimal / (R) Step, In-panel, Side Spoiler - Scratch - Small / (R) Step, In-panel, Side Spoiler - Repair mark - Yes / (R) Front Door, Molding - Scratch - Small / (R) Center Panel - Scratch - Minimal / (R) Side Gate - Scratch - Large / Rear Gate - Rust, Corrosion - Medium / (L) Side Gate - Scratch - Large / (L) Center Panel - Repair mark - Yes / (L) Front Door, Molding - Repair mark - Yes / (L) Center Panel - Scratch - Small / (L) Step, In-panel, Side Spoiler - Repair mark - Yes / (L) Front Door, Molding - Scratch - Small / Front Bumper, Grille, Lamps - Scratch &amp; Dent - Medium / (L) Front Fender, Molding - Scratch - Minimal / Front Panel - Scratch - Minimal / Roof - Rust, Corrosion - Small</p> |
