## General Information

| Make | Mitsubishi | Model | Mirage |
| Registration No. | DCD3323 | Chassis No. | PAEA13RJTSA014089 |

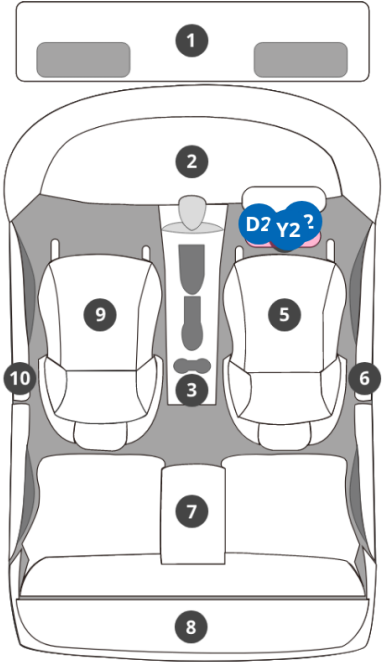
| Interior Evaluation : <span style="color: red; font-weight: bold;">A</span> | Exterior Evaluation : <span style="color: red; font-weight: bold;">C</span> |
|---|---|
| <b>Remarks</b><br>(L) Front Floor Mat - Worked - Small / (L) Front Floor Mat - Grime - Small / Mat Other - Grime - Small | <b>Remarks</b><br>(R) Mirror - Scratch - Minimal / (R) Front Fender, Molding - Scratch - Minimal / (R) Rear Door, Molding - Scratch - Small / (R) Front Door, Molding - Scratch - Minimal / (R) Rear Fender, Molding - Scratch - Medium / Rear Bumper, Lamps, Panels - Scratch - Medium / Trunk Hood, Rear Gate - Scratch - Minimal / (L) Rear Fender, Molding - Scratch - Minimal / (L) Rear Door, Molding - Scratch - Minimal / (L) Front Door, Molding - Scratch - Small / (L) Mirror - Scratch - Small / (L) Front Fender, Molding - Scratch - Minimal / Front Bumper, Grille, Lamps - Scratch - Small / Bonnet, Headlight - Scratch - Minimal / Roof - Scratch - Minimal |
