## General Information

| Make | Mitsubishi | Model | L300 |
| Registration No. | EAL2556 | Chassis No. | PAEL65YSSB003786 |

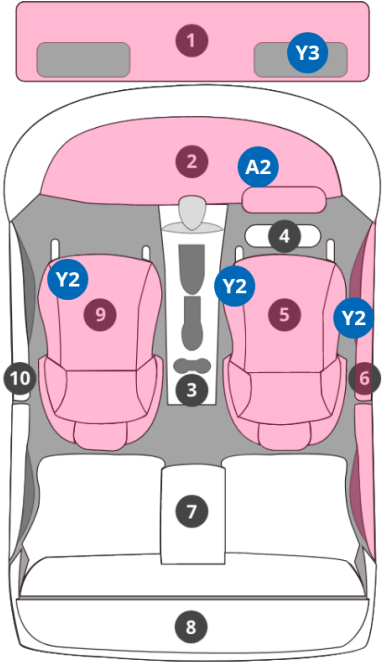
| Interior Evaluation : <b>B</b> | Exterior Evaluation : <b>E</b> |
|---|---|
| <p><b>Remarks</b><br/>(R) Front Trim - Grime - Small / Ceiling - Grime - Medium / (R) Front Seat - Grime - Small / (L) Front Seat - Grime - Small / Dashboard - Worn, Scratch, Cut, Crack - Small</p> | <p><b>Remarks</b><br/>(L) Rear Corner Panel - Repair Traces - Yes / (R) Rear Corner Panel - Repair Traces - Yes / (R) Front Fender, Molding - Scratch - Small / (R) Mirror - Scratch - Minimal / (R) Front Door, Molding - Scratch - Minimal / (R) Center Panel - Scratch - Small / (R) Side Gate - Scratch - Medium / Rear Gate - Rust, Corrosion - Medium / Rear Bumper, Lamps, Panels - Scratch - Medium / (L) Side Gate - Rust, Corrosion - Large / Cargo Bed Floor - Rust, Corrosion - Large / Cab Back Panel - Rust, Corrosion - Medium / (L) Front Door, Molding - Scratch - Small / (L) Center Panel - Scratch - Minimal / (L) Mirror - Scratch - Minimal / (L) Front Fender, Molding - Scratch - Minimal / Front Panel - Scratch - Small / Front Bumper, Grille, Lamps - Scratch - Small / Roof - Scratch - Small</p> |
