## General Information

| Make | Mitsubishi | Model | Mirage |
| YOM | 2024 | Odo Meter Reading | 35,190 |
| Registration No. | LAM9181 | Chassis No. | PAEA03RJRPA007532 |

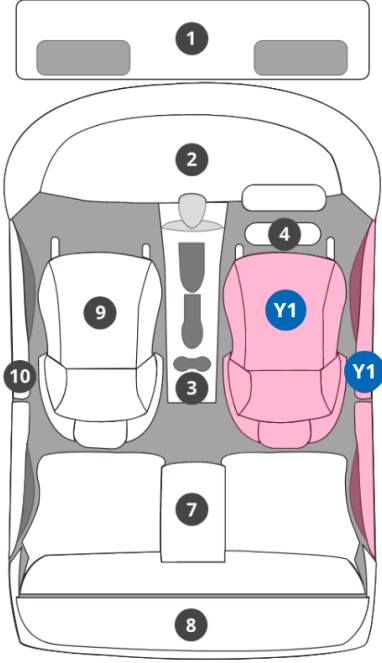
| Interior Evaluation : <b>A</b> | Exterior Evaluation : <b>C</b> |
|---|---|
| <b>Remarks</b><br>(R) Front Seat - Grime - Minimal / (R) Front Trim - Grime - Minimal | <b>Remarks</b><br>(R) Front Door - Repair Traces - Yes / (R) Front Fender - Repair Traces - Yes / Bonnet - Repair Traces - Yes / (L) Front Fender - Repair Traces - Yes / (L) Front Door - Repair Traces - Yes / (L) Step - Repair Traces - Yes / (L) Rear Door - Repair Traces - Yes / (L) Rear Fender - Repair Traces - Yes / Trunk Hood, Rear Gate - Repair Traces - Yes / (R) Rear Fender - Repair Traces - Yes / (R) Rear Door - Repair Traces - Yes / Roof - Repair Traces - Yes / Overall Exterior - Re-Paint Uneven - Yes / (R) Front Fender, Molding - Scratch - Minimal / (R) Front Door, Molding - Scratch - Minimal / (R) Rear Door, Molding - Scratch - Minimal / (R) Rear Fender, Molding - Scratch - Minimal / (R) Step, In-panel, Side Spoiler - Scratch - Minimal / (L) Front Fender, Molding - Repair mark - Difference in Color / (L) Front Door, Molding - Scratch - Medium / (L) Rear Door, Molding - Scratch - Large / (L) Rear Fender, Molding - Scratch - Minimal / (L) Step, In-panel, Side Spoiler - Scratch - Minimal / Front Bumper, Grille, Lamps - Crack, Gap - Medium / Bonnet, Headlight - Scratch - Small / Trunk Hood, Rear Gate - Scratch - Small / Rear Bumper, Lamps, Panels - Scratch - Small |
