## General Information

| Make | Ford | Model | EcoSport |
| Registration No. | FAA2469 | Chassis No. | MPBSXXMXKSGC45553 |

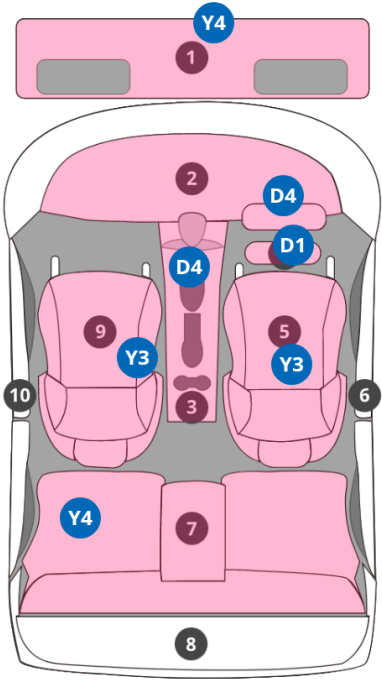
| Interior Evaluation : <span style="color: red;">D</span> | Exterior Evaluation : <span style="color: red;">C</span> |
|---|---|
| <b>Remarks</b><br>Ceiling - Grime - Large / Glove Box - Loose, Deformed - Large / Console, Switchs, Vents - Loose, Deformed - Large / (R) Front Seat - Grime - Medium / (L) Front Seat - Grime - Medium / Rear Seat - Grime - Large / Carpet - Worked - Minimal | <b>Remarks</b><br>(L) Front Fender - Repair Traces - Yes / Trunk Hood, Rear Gate - Repair Traces - Yes / (R) Front Door, Molding - Dent - Minimal / (L) Front Door, Molding - Scratch & Dent - Medium / (L) Rear Door, Molding - Scratch - Small / Front Bumper, Grille, Lamps - Scratch - Large |
