## General Information

| Make | Nissan | Model | Navara |
| Registration No. | GAJ1772 | Chassis No. | MNTCC4D23Z0040004 |

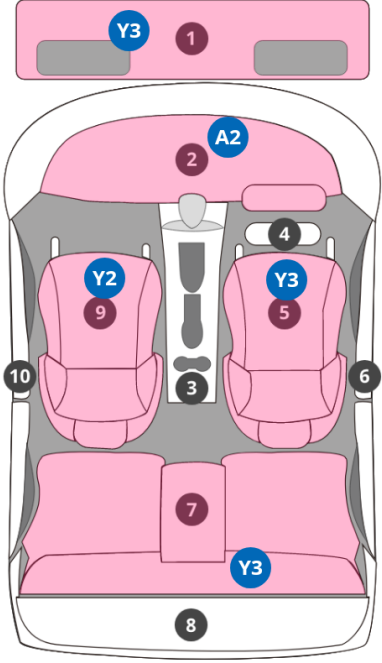
| Interior Evaluation : <b>B</b> | Exterior Evaluation : <b>D</b> |
|---|---|
| <p><b>Remarks</b></p> <p>Rear Seat - Grime - Medium / (R) Front Seat - Grime - Medium / Ceiling - Grime - Medium / (L) Front Seat - Grime - Small / Dashboard - Worn, Scratch, Cut, Crack - Small</p> | <p><b>Remarks</b></p> <p>(R) Front Door - Repair Traces - Yes / (R) Step - Repair Traces - Yes / (R) Front Fender - Repair Traces - Yes / Bonnet - Repair Traces - Yes / (L) Front Fender - Repair Traces - Yes / (L) Rear Door - Repair Traces - Yes / (L) Rear Corner Panel - Repair Traces - Yes / (R) Rear Door - Repair Traces - Yes / Roof - Repair Traces - Yes / Front Bumper, Grille, Lamps - Crack, Gap - Large / Bonnet, Headlight - Repair mark - Yes / (L) Front Fender, Molding - Scratch &amp; Dent - Large / (R) Front Fender, Molding - Scratch - Small / (R) Front Door, Molding - Scratch - Small / (L) Front Door, Molding - Dent - Small / (L) Rear Door, Molding - Dent - Small / (R) Rear Door, Molding - Crack, Gap - Small / Rear Bumper, Lamps, Panels - Crack, Gap - Large / (R) Side Gate - Dent - Small / (R) Step, In-panel, Side Spoiler - Repair mark - Yes</p> |
