## General Information

| Make | Toyota | Model | Fortuner |
| Registration No. | NKN7978 | Chassis No. | MHFCB3GS1S0498250 |

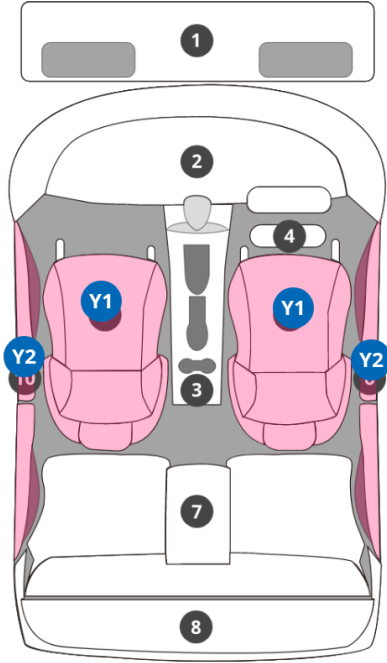
| Interior Evaluation : <span style="color: red;">A</span> | Exterior Evaluation : <span style="color: red;">D</span> |
|---|---|
| <b>Remarks</b><br>(R) Front Seat - Grime - Minimal / (L) Front Seat - Grime - Minimal / (L) Front Trim - Grime - Small / (R) Front Trim - Grime - Small | <b>Remarks</b><br>(R) Front Door - Repair Traces - Yes / (R) Front Fender - Repair Traces - Yes / Bonnet - Repair Traces - Yes / (L) Front Fender - Repair Traces - Yes / (L) Front Door - Repair Traces - Yes / (L) Rear Door - Repair Traces - Yes / (L) Rear Fender - Repair Traces - Yes / Trunk Hood, Rear Gate - Repair Traces - Yes / (R) Rear Fender - Repair Traces - Yes / (R) Rear Fender - Replaced - Yes / (R) Rear Door - Repair Traces - Yes / Roof - Repair Traces - Yes / Overall Exterior - Full Re-Paint in same color - Yes / (R) Front Fender, Molding - Scratch - Small / (R) Front Door, Molding - Scratch - Small / (R) Rear Door, Molding - Scratch - Small / (R) Step, In-panel, Side Spoiler - Scratch - Small / (L) Front Fender, Molding - Scratch - Small / (L) Front Door, Molding - Scratch - Small / (L) Step, In-panel, Side Spoiler - Scratch - Minimal / (L) Rear Door, Molding - Partially Missing - Yes / (L) Rear Door, Molding - Scratch - Medium / (L) Rear Fender, Molding - Scratch - Small / Front Bumper, Grille, Lamps - Scratch - Small / Bonnet, Headlight - Scratch - Small / Trunk Hood, Rear Gate - Modified - Small / Rear Bumper, Lamps, Panels - Scratch - Small |

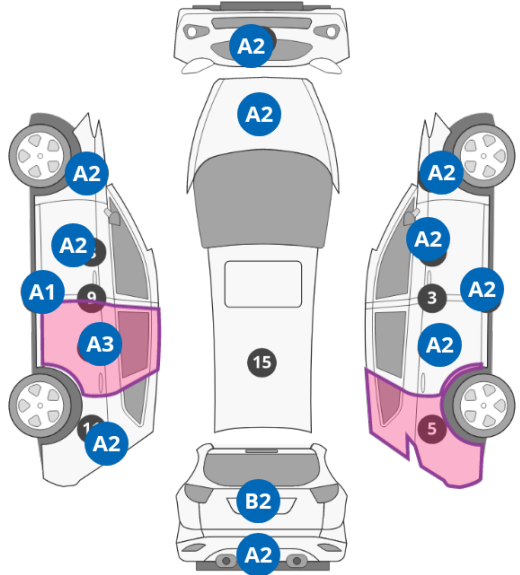
| Interior Evaluation : <span style="color: red;">A</span> | Exterior Evaluation : <span style="color: red;">D</span> |
|---|---|
| <b>Remarks</b><br>Left Front Pillar - Condition of Welding ? - Yes / Left Center Pillar - Condition of Welding ? - Yes / Right Tyre House - Traces of Bending, or Marks of Panel Repair ? - Yes / Right Center Pillar - Condition of Welding ? - Yes | <b>Remarks</b><br>Radiator Water Pump - Leak - Yes / Battery - Weak - Yes / Spare Key - Issue - Unexist |
