## General Information

| Make | Suzuki | Model | Carry |
| YOM | 2023 | Mileage | 15,137 |
| Registration No. | NHE7290 | Chassis No. | MHYDC61TXPJ213154 |

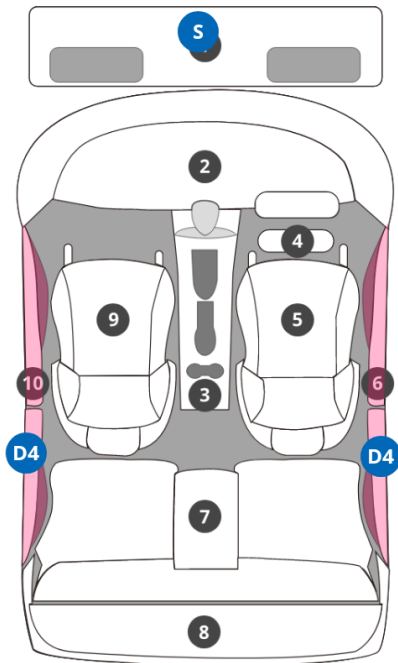
| Interior Evaluation : <span style="color: red;">C</span> | Exterior Evaluation : <span style="color: red;">E</span> |
|---|---|
| <b>Remarks</b><br>Overall Interior - Smell - Yes / (R) Rear Trim - Worked - Large / (L) Rear Trim - Worked - Large | <b>Remarks</b><br>(R) Front Door - Repair Traces - Yes / Front Panel - Repair Traces - Yes / (L) Front Door - Repair Traces - Yes / (L) Rear Corner Panel - Repair Traces - Yes / (R) Rear Corner Panel - Repair Traces - Yes / Roof - Repair Traces - Yes / Rear Bumper, Lamps, Panels - Scratch - Small / (L) Rear Wheel, Cover - Scratch, Corrosion - Bent / (L) Side Gate - Scratch & Dent - Large / (L) Front Door, Molding - Scratch - Medium / Front Panel - Dent - Small / Front Bumper, Grille, Lamps - Scratch - Large / (R) Front Fender, Molding - Scratch - Small / (R) Front Door, Molding - Scratch & Dent - Medium / (R) Side Gate - Scratch - Large / Roof - Dent - Large |
