## General Information

| Make | Toyota | Model | Hilux Tamaraw |
| Registration No. | NKQ1150 | Chassis No. | PAHACACAXS6425009 |

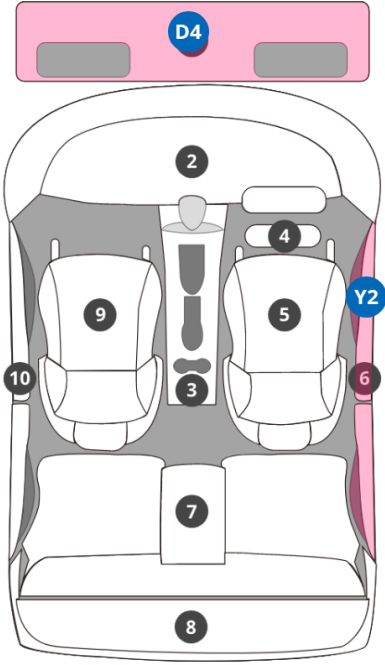
| Interior Evaluation : <b>C</b> | Exterior Evaluation : <b>E</b> |
|---|---|
| <b>Remarks</b><br>(R) Front Trim - Grime - Small / Ceiling - Loose, Deformed - Large | <b>Remarks</b><br>(R) Front Fender, Molding - Scratch - Minimal / (R) Front Door, Molding - Scratch - Minimal / (R) Step, In-panel, Side Spoiler - Scratch & Dent - Medium / (R) Side Gate - Scratch & Dent - Large / Rear Gate - Scratch - Medium / Rear Bumper, Lamps, Panels - Scratch - Large / Cargo Bed Floor - Scratch - Large / (L) Side Gate - Partially Missing - Yes / (L) Center Panel - Scratch - Minimal / (L) Mirror - Scratch - Minimal / (L) Front Door, Molding - Scratch & Dent - Minimal / Roof - Scratch & Dent - Large / Bonnet, Headlight - Scratch & Dent - Minimal / (L) Front Fender, Molding - Scratch - Minimal / Front Bumper, Grille, Lamps - Scratch - Medium / (L) Side Gate - Scratch - Large |
