## General Information

| Make | Toyota | Model | Innova |
| Registration No. | DBN5090 | Chassis No. | PA2JA8EM4P0130059 |

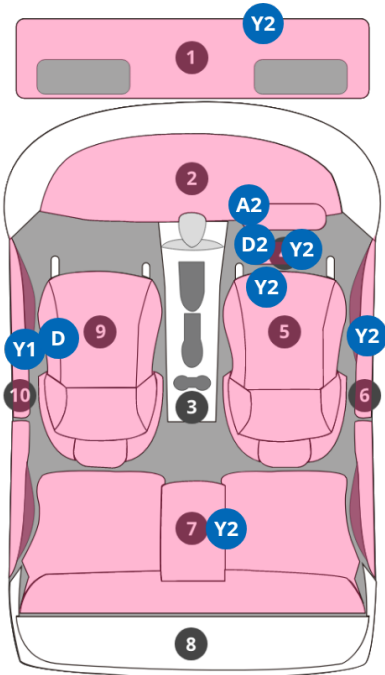
| Interior Evaluation : <b>B</b> | Exterior Evaluation : <b>E</b> |
|---|---|
| <b>Remarks</b><br>(R) Front Floor Mat - Grime - Small / (L) Front Floor Mat - Worked - Small / (R) Front Trim - Grime - Small / (R) Front Seat - Grime - Small / (L) Front Seat - Worn - Yes / Ceiling - Grime - Small / Rear Seat - Grime - Small / Glove Box - Worn, Scratch, Cut, Crack - Small | <b>Remarks</b><br>(R) Front Fender - Repair Traces - Yes / (R) Front Fender, Molding - Scratch - Small / (R) Mirror - Scratch - Minimal / (R) Front Door, Molding - Scratch - Medium / (R) Rear Door, Molding - Scratch - Medium / (R) Rear Fender, Molding - Scratch - Medium / Rear Bumper, Lamps, Panels - Dent - Medium / Trunk Hood, Rear Gate - Scratch & Dent - Small / (L) Rear Fender, Molding - Scratch - Minimal / (L) Rear Door, Molding - Scratch - Small / (L) Front Door, Molding - Scratch - Small / (L) Mirror - Scratch - Minimal / (L) Front Fender, Molding - Scratch - Medium / Front Bumper, Grille, Lamps - Scratch - Large / Bonnet, Headlight - Scratch - Small / Roof - Scratch - Small |
