## General Information

| Make | Toyota | Model | Vios |
| Registration No. | NEC1489 | Chassis No. | PA1B18F36S4287768 |

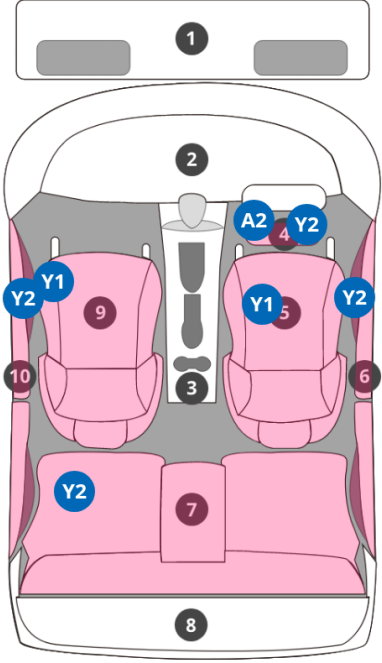
| Interior Evaluation : <b>B</b> | Exterior Evaluation : <b>E</b> |
|---|---|
| <p><b>Remarks</b><br/>Rear Seat - Grime - Small / (R) Front Trim - Grime - Small / (R) Front Seat - Grime - Minimal / (R) Front Floor Mat - Grime - Small / (L) Front Trim - Grime - Small / (L) Front Seat - Grime - Minimal / (L) Front Floor Mat - Cut, Crack - Small</p> | <p><b>Remarks</b><br/>(R) Front Fender - Repair Traces - Yes / (R) Front Fender, Molding - Repair mark - Yes / (L) Front Fender, Molding - Scratch - Small / (L) Step, In-panel, Side Spoiler - Scratch - Minimal / (L) Front Door, Molding - Scratch - Small / (L) Front Door, Molding - Repair mark - Yes / (L) Rear Door, Molding - Scratch - Small / (L) Rear Fender, Molding - Scratch - Small / Rear Bumper, Lamps, Panels - Repair mark - Yes / Rear Bumper, Lamps, Panels - Scratch - Medium / Trunk Hood, Rear Gate - Scratch - Minimal / (R) Rear Fender, Molding - Scratch - Small / (R) Step, In-panel, Side Spoiler - Scratch - Small / (R) Rear Door, Molding - Scratch - Small / (R) Front Door, Molding - Scratch - Small / (R) Mirror - Scratch - Minimal / (R) Front Fender, Molding - Scratch - Minimal / Front Bumper, Grille, Lamps - Scratch - Medium / Bonnet, Headlight - Scratch - Small / Roof - Scratch - Minimal / Front Bumper, Grille, Lamps - Repair mark - Yes</p> |
