## General Information

| Make | Toyota | Model | Hilux Tamaraw |
| Registration No. | NEK9286 | Chassis No. | PAHACACA9S6431366 |

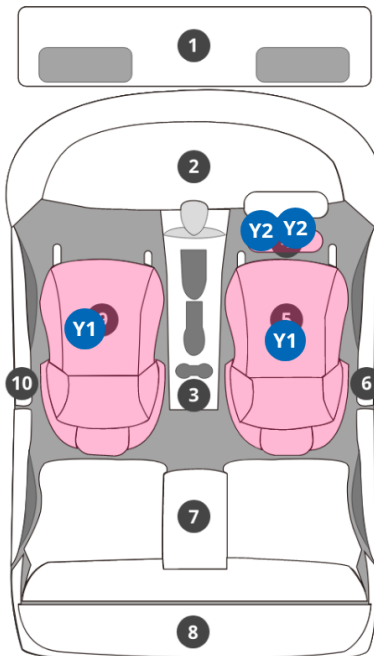
| <div> <div>Remarks</div> <div>(L) Front Seat - Grime - Minimal / (R) Front Seat - Grime - Minimal / (R) Front Floor Mat - Grime - Small / (L) Front Floor Mat - Grime - Small</div> </div> | <div> <div>Remarks</div> <div>(R) Side Gate - Scratch &amp; Dent - Minimal / (R) Front Door, Molding - Scratch &amp; Dent - Minimal / (R) Center Panel - Scratch - Minimal / (R) Front Fender, Molding - Scratch &amp; Dent - Minimal / Bonnet, Headlight - Scratch &amp; Dent - Minimal / (L) Front Fender, Molding - Scratch &amp; Dent - Minimal / (L) Front Door, Molding - Scratch &amp; Dent - Minimal / (L) Step, In-panel, Side Spoiler - Scratch - Small / (L) Side Gate - Scratch - Small / (L) Guard Frame - Scratch - Small / Cargo Bed Floor - Scratch - Small / Rear Gate - Scratch &amp; Dent - Small / Rear Bumper, Lamps, Panels - Scratch &amp; Dent - Small / Front Bumper, Grille, Lamps - Scratch - Small / (R) Step, In-panel, Side Spoiler - Scratch - Minimal / Roof - Scratch &amp; Dent - Minimal</div> </div> |

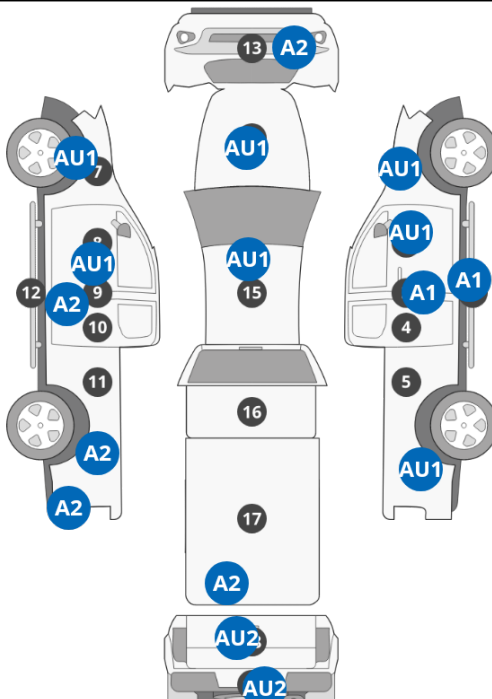
with LTO plate, with spare tire, with jack and inc tools, with manual and warranty booklet, scratches on taillight and headlight, minor scratches on exterior, no reverse camera.
