## General Information

| Make | Suzuki | Model | Carry |
| Registration No. | NHB5004 | Chassis No. | MHYDC61T0PJ210750 |

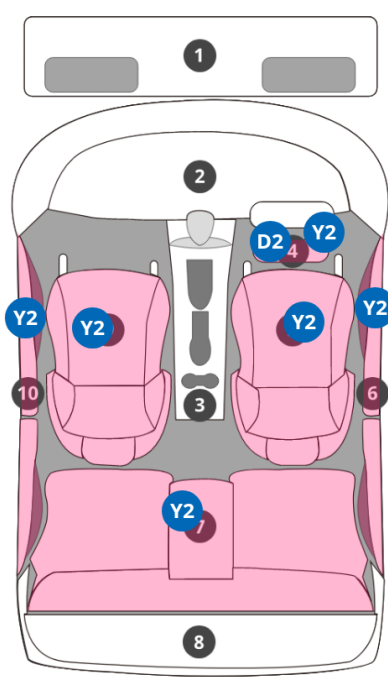
| <div> <div>Interior Evaluation :</div> <div>B</div> </div> | <div> <div>Exterior Evaluation :</div> <div>D</div> </div> |
| <div> <div>Remarks</div> <div>(L) Front Seat - Grime - Small / (R) Front Seat - Grime - Small / Rear Seat - Grime - Small / (L) Front Trim - Grime - Small / (R) Front Trim - Grime - Small / (L) Front Floor Mat - Crinkle - Small / (R) Front Floor Mat - Grime - Small</div> </div> | <div> <div>Remarks</div> <div>Front Panel - Replaced - Yes / Roof - Repair Traces - Yes / (R) Side Gate - Scratch &amp; Dent - Small / (R) Front Door, Molding - Scratch &amp; Dent - Small / (R) Center Panel - Scratch &amp; Dent - Small / Front Bumper, Grille, Lamps - Scratch - Medium / (R) Step, In-panel, Side Spoiler - Scratch &amp; Dent - Small / Front Panel - Scratch - Small / (L) Front Fender, Molding - Scratch &amp; Dent - Minimal / (R) Front Fender, Molding - Scratch - Minimal / (L) Front Door, Molding - Scratch &amp; Dent - Minimal / (L) Step, In-panel, Side Spoiler - Scratch - Minimal / (L) Center Panel - Scratch - Minimal / Overall Exterior - Faded(Color, Gloss) - Yes / Roof - Dent - Medium / (L) Side Gate - Rust, Corrosion - Medium / Rear Gate - Scratch &amp; Dent - Small / Rear Bumper, Lamps, Panels - Scratch &amp; Dent - Small / Cargo Bed Floor - Scratch &amp; Dent - Small</div> </div> |

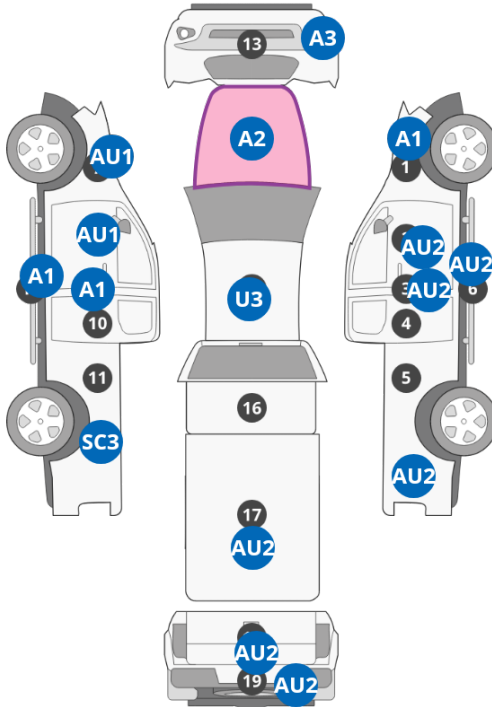
with LTO plate, with spare tire, with warranty and manual booklet, no jack and tools, no spare key scratches on exterior, scratches on taillight and headlight.
