## General Information

| Make | Toyota | Model | Vios |
| YOM | 2024 | Odo Meter Reading | 45,234 |
| Registration No. | NHQ6835 | Chassis No. | PA1B18F35R4249376 |

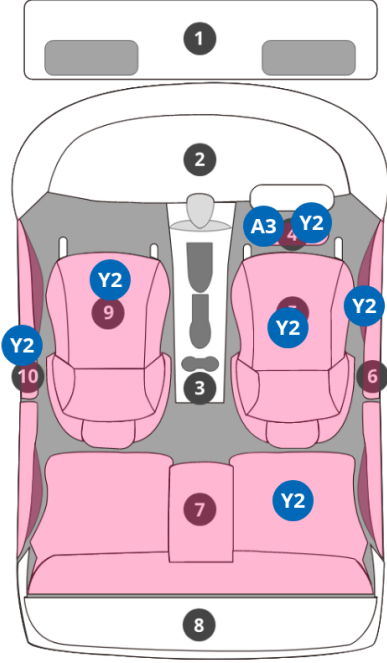
| Interior Evaluation : <b>B</b> | Exterior Evaluation : <b>E</b> |
|---|---|
| <p><b>Remarks</b></p> <p>(R) Front Floor Mat - Grime - Small / (R) Front Trim - Grime - Small / (L) Front Trim - Grime - Small / (L) Front Floor Mat - Cut, Crack - Medium / (R) Front Seat - Grime - Small / (L) Front Seat - Grime - Small / Rear Seat - Grime - Small</p> | <p><b>Remarks</b></p> <p>Bonnet - Repair Traces - Yes / (L) Front Fender - Repair Traces - Yes / (L) Rear Door - Repair Traces - Yes / (L) Rear Fender - Repair Traces - Yes / Trunk Hood, Rear Gate - Repair Traces - Yes / Rear End Panel - Repair Traces - Yes / Trunk Hood, Rear Gate - Repair mark - Yes / Rear Bumper, Lamps, Panels - Repair mark - Yes / (R) Rear Fender, Molding - Repair mark - Yes / (L) Rear Fender, Molding - Repair mark - Yes / Overall Exterior - Full Re-Paint in same color - Yes / (L) Rear Fender, Molding - Crack, Gap - Large / (L) Rear Door, Molding - Scratch &amp; Dent - Large / (L) Step, In-panel, Side Spoiler - Scratch &amp; Dent - Small / (L) Mirror - Scratch - Small / (L) Front Fender, Molding - Scratch &amp; Dent - Small / (L) Front Door, Molding - Scratch - Small / Trunk Hood, Rear Gate - Scratch - Small / Rear Bumper, Lamps, Panels - Scratch - Medium / (R) Rear Fender, Molding - Scratch - Small / (R) Rear Door, Molding - Scratch - Small / (R) Step, In-panel, Side Spoiler - Scratch - Small / (R) Front Door, Molding - Scratch - Small / (R) Front Fender, Molding - Scratch - Minimal / Front Bumper, Grille, Lamps - Scratch - Small / Bonnet, Headlight - Scratch &amp; Dent - Medium / Roof - Scratch &amp; Dent - Small</p> |
