## General Information

| Make | Toyota | Model | Innova |
| Registration No. | DBF4522 | Chassis No. | PA2JA8EM1M0097355 |

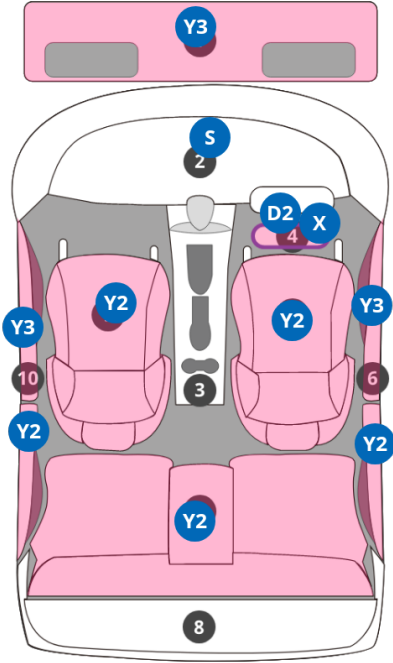
| Interior Evaluation : <span style="color: red;">C</span> | Exterior Evaluation : <span style="color: red;">E</span> |
| <b>Remarks</b><br>(R) Rear Trim - Grime - Small / (R) Front Trim - Grime - Medium / (R) Front Floor Mat - Missing - Yes / (L) Rear Trim - Grime - Small / (L) Front Trim - Grime - Medium / (L) Front Floor Mat - Worked - Small / (R) Front Seat - Grime - Small / (L) Front Seat - Grime - Small / Rear Seat - Grime - Small / Ceiling - Grime - Medium / Overall Interior - Smell - Yes / Overall Interior - Worn as per age - Yes | <b>Remarks</b><br>(R) Front Fender - Repair Traces - Yes / (L) Front Fender - Repair Traces - Yes / (R) Rear Fender - Repair Traces - Yes / (R) Rear Door - Repair Traces - Yes / Roof - Repair Traces - Yes / (R) Front Fender, Molding - Crack, Gap - Large / (R) Step, In-panel, Side Spoiler - Scratch & Dent - Small / (R) Rear Door, Molding - Repair mark - Yes / (R) Rear Fender, Molding - Repair mark - Yes / (R) Front Door, Molding - Scratch & Dent - Small / Overall Exterior - Worn as per age - Yes / (R) Rear Door, Molding - Scratch & Dent - Small / (R) Rear Fender, Molding - Scratch - Small / Trunk Hood, Rear Gate - Scratch & Dent - Small / Rear Bumper, Lamps, Panels - Crack, Gap - Small / (L) Rear Fender, Molding - Scratch & Dent - Small / (L) Step, In-panel, Side Spoiler - Scratch & Dent - Medium / (L) Rear Door, Molding - Scratch & Dent - Small / (L) Front Door, Molding - Scratch & Dent - Medium / (L) Mirror - Scratch - Minimal / (L) Front Fender, Molding - Scratch - Small / Front Bumper, Grille, Lamps - Scratch - Large / Bonnet, Headlight - Scratch & Dent - Small / Roof - Scratch & Dent - Small / (R) Mirror - Scratch - Minimal |
