## General Information

| Make | Toyota | Model | Rush |
| Registration No. | KAD8192 | Chassis No. | MHKE8FF2PKK005248 |

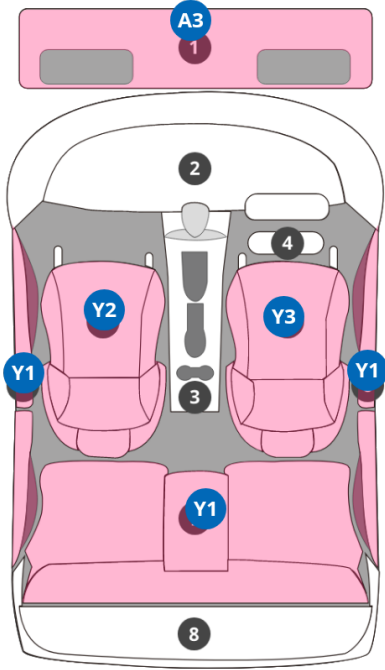
| Interior Evaluation : <b>B</b> | Exterior Evaluation : <b>E</b> |
| <b>Remarks</b><br>(L) Front Trim - Grime - Minimal / (R) Front Trim - Grime - Minimal / (R) Front Seat - Grime - Medium / (L) Front Seat - Grime - Small / Sunvisor, Sunglass Holder - Cut, Crack - Medium / Rear Seat - Grime - Minimal | <b>Remarks</b><br>(R) Front Door - Repair Traces - Yes / (R) Front Fender - Repair Traces - Yes / (L) Front Fender - Repair Traces - Yes / (L) Front Door - Repair Traces - Yes / (L) Rear Door - Repair Traces - Yes / (L) Rear Fender - Repair Traces - Yes / Trunk Hood, Rear Gate - Repair Traces - Yes / (R) Rear Fender - Repair Traces - Yes / (R) Rear Door - Repair Traces - Yes / Roof - Repair Traces - Yes / (R) Mirror - Scratch - Minimal / (R) Front Door, Molding - Rust, Corrosion - Medium / (R) Front Fender, Molding - Partially Missing - Yes / (R) Rear Door, Molding - Repair mark - Difference in Color / (R) Rear Fender, Molding - Scratch & Dent - Small / (L) Front Fender, Molding - Partially Missing - Yes / (L) Front Door, Molding - Scratch - Small / (L) Mirror - Scratch - Small / (L) Rear Door, Molding - Scratch - Small / (L) Rear Fender, Molding - Scratch - Small / Front Bumper, Grille, Lamps - Crack, Gap - Large / Bonnet, Headlight - Scratch - Small / Trunk Hood, Rear Gate - Scratch - Small / Rear Bumper, Lamps, Panels - Scratch - Small |
