## General Information

| Make | Toyota | Model | Avanza |
| YOM | 2024 | Odo Meter Reading | 30,853 |
| Registration No. | NFR1435 | Chassis No. | MHFAA1BY3R0024661 |

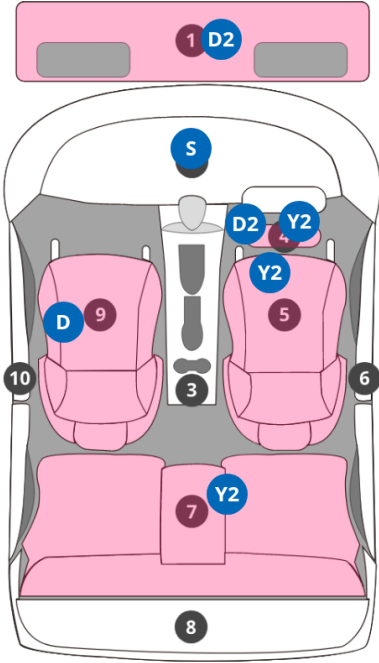
| Interior Evaluation : <b>B</b> | Exterior Evaluation : <b>E</b> |
| <p><b>Remarks</b><br/>(L) Front Floor Mat - Worked - Small / (L) Front Seat - Worn - Yes / (R) Front Seat - Grime - Small / (R) Front Floor Mat - Grime - Small / Ceiling - Crinkle - Small / Overall Interior - Smell - Yes / Rear Seat - Grime - Small</p> | <p><b>Remarks</b><br/>(L) Rear Door - Repair Traces - Yes / (L) Rear Fender - Repair Traces - Yes / (R) Front Fender, Molding - Scratch &amp; Dent - Medium / (R) Mirror - Scratch - Medium / (R) Mirror - Faded(Color, Gloss) - Yes / Overall Exterior - Faded(Color, Gloss) - Yes / Overall Exterior - Full Re-Paint in same color - Yes / (R) Step, In-panel, Side Spoiler - Scratch &amp; Dent - Medium / (R) Front Door, Molding - Scratch - Small / (R) Rear Door, Molding - Scratch &amp; Dent - Medium / (R) Rear Fender, Molding - Scratch &amp; Dent - Medium / Rear Bumper, Lamps, Panels - Repair mark - Yes / Rear Bumper, Lamps, Panels - Scratch &amp; Dent - Medium / Trunk Hood, Rear Gate - Scratch &amp; Dent - Medium / (L) Rear Fender, Molding - Scratch &amp; Dent - Large / (L) Rear Door, Molding - Scratch &amp; Dent - Large / (L) Front Door, Molding - Scratch - Medium / (L) Step, In-panel, Side Spoiler - Dent - Small / (L) Mirror - Scratch - Small / (L) Front Fender, Molding - Scratch - Small / Front Bumper, Grille, Lamps - Repair mark - Yes / Front Bumper, Grille, Lamps - Scratch &amp; Dent - Large / Bonnet, Headlight - Scratch &amp; Dent - Small / Roof - Scratch - Minimal</p> |
