## General Information

| Make | Toyota | Model | Fortuner |
| YOM | 2023 | Odo Meter Reading | 94,703 |
| Registration No. | NIL3340 | Chassis No. | MHFJB8GS8P1590428 |

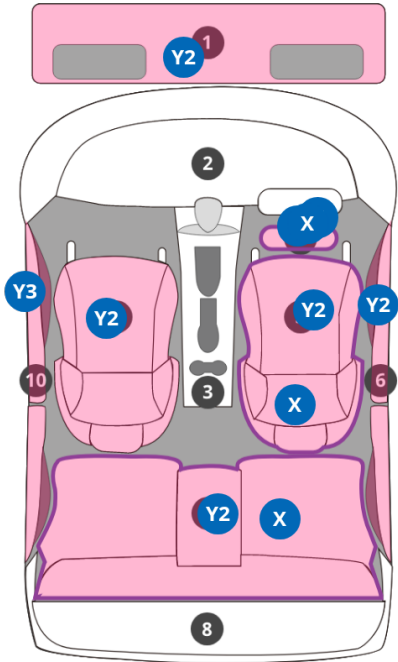
| Interior Evaluation : <b>B</b> | Exterior Evaluation : <b>D</b> |
| <b>Remarks</b><br>(L) Front Seat - Grime - Small / (R) Front Seat - Grime - Small / Rear Seat - Grime - Small / (L) Front Trim - Grime - Medium / (R) Front Trim - Grime - Small / (R) Front Seat Head Rest - Missing - Yes / Rear Seat Head Rest - Missing - Yes / (L) Front Floor Mat - Missing - Yes / (R) Front Floor Mat - Missing - Yes / Mat Other - Missing - Yes / Ceiling - Grime - Small | <b>Remarks</b><br>(R) Front Fender - Repair Traces - Yes / Bonnet - Repair Traces - Yes / (L) Front Fender - Repair Traces - Yes / Trunk Hood, Rear Gate - Scratch & Dent - Minimal / (R) Rear Fender, Molding - Scratch - Medium / (R) Rear Door, Molding - Scratch - Medium / (R) Front Door, Molding - Scratch - Medium / (R) Step, In-panel, Side Spoiler - Scratch - Medium / (R) Front Fender, Molding - Scratch & Dent - Small / Bonnet, Headlight - Scratch & Dent - Small / Front Bumper, Grille, Lamps - Scratch & Dent - Medium / (L) Front Fender, Molding - Scratch & Dent - Small / (L) Front Door, Molding - Scratch & Dent - Small / (L) Rear Door, Molding - Scratch & Dent - Minimal / (L) Rear Fender, Molding - Scratch & Dent - Small / Rear Bumper, Lamps, Panels - Scratch - Small / Roof - Scratch & Dent - Small |
