## General Information

| Make | Toyota | Model | Hilux Tamaraw |
| Registration No. | NKU5810 | Chassis No. | PAHACACA1S6424203 |

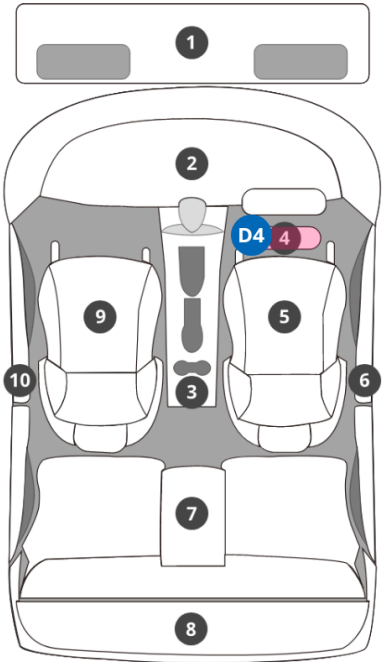
| Interior Evaluation : <span>C</span> | Exterior Evaluation : <span>C</span> |
|---|---|
| <b>Remarks</b><br>(L) Front Floor Mat - Worked - Large | <b>Remarks</b><br>Roof - Repair Traces - Yes / (R) Side Gate - Scratch - Medium / Cargo Bed Floor - Scratch & Dent - Large / Rear Bumper, Lamps, Panels - Scratch - Small / (L) Guard Frame - Scratch - Small / Cab Back Panel - Scratch - Medium / (R) Front Door, Molding - Scratch - Small |
