## General Information

| Make | Toyota | Model | Hilux Tamaraw |
| Registration No. | CCQ3095 | Chassis No. | PAHACACA8S6422867 |

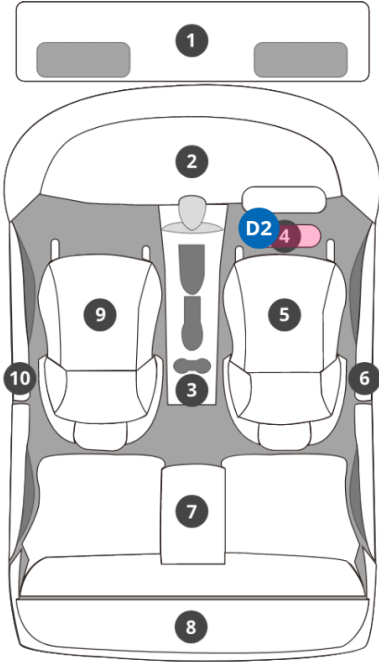
| Interior Evaluation : <span style="color: red;">A</span> | Exterior Evaluation : <span style="color: red;">E</span> |
| <b>Remarks</b><br>(L) Front Floor Mat - Worked - Small | <b>Remarks</b><br>(R) Side Gate - Scratch - Large / Rear Gate - Scratch - Large / Cargo Bed Floor - Scratch - Large / (L) Side Gate - Scratch - Large / Front Bumper, Grille, Lamps - Scratch - Large / (L) Front Door, Molding - Scratch - Minimal / Bonnet, Headlight - Dent - Small / (R) Front Door, Molding - Scratch - Medium / Roof - Scratch - Minimal |
