## General Information

| Make | Toyota | Model | Vios |
| YOM | 2025 | Odo Meter Reading | 30,083 |
| Registration No. | ZAF6857 - NO ORCR | Chassis No. | PA1B18F31S4285457 |

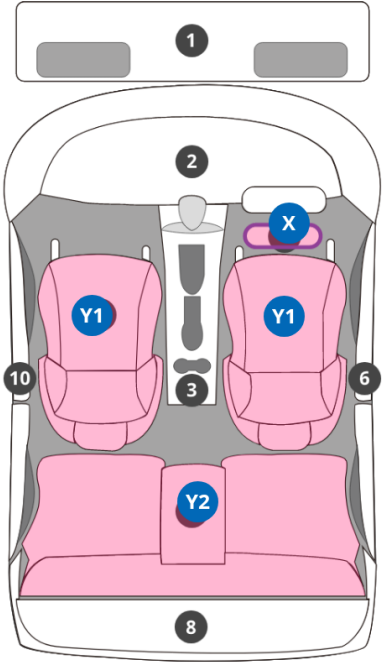
| Interior Evaluation : <b>B</b> | Exterior Evaluation : <b>D</b> |
| <b>Remarks</b><br>(R) Front Seat - Grime - Minimal / (L) Front Seat - Grime - Minimal / Rear Seat - Grime - Small / Mat Other - Missing - Yes | <b>Remarks</b><br>(R) Front Fender, Molding - Scratch - Small / (R) Mirror - Scratch - Minimal / (R) Front Door, Molding - Scratch - Small / (R) Step, In-panel, Side Spoiler - Scratch - Small / (R) Rear Door, Molding - Scratch - Medium / (R) Rear Fender, Molding - Scratch - Medium / (L) Front Fender, Molding - Scratch - Small / (L) Front Door, Molding - Scratch - Medium / (L) Rear Door, Molding - Scratch - Medium / (L) Rear Fender, Molding - Scratch - Medium / Front Bumper, Grille, Lamps - Crack, Gap - Medium / Bonnet, Headlight - Scratch - Minimal / Trunk Hood, Rear Gate - Scratch - Minimal / Rear Bumper, Lamps, Panels - Scratch - Small |
