## General Information

| Make | Toyota | Model | Vios |
| YOM | 2024 | Odo Meter Reading | 42,420 |
| Registration No. | DBJ8031 | Chassis No. | PA1B18F38P4226011 |

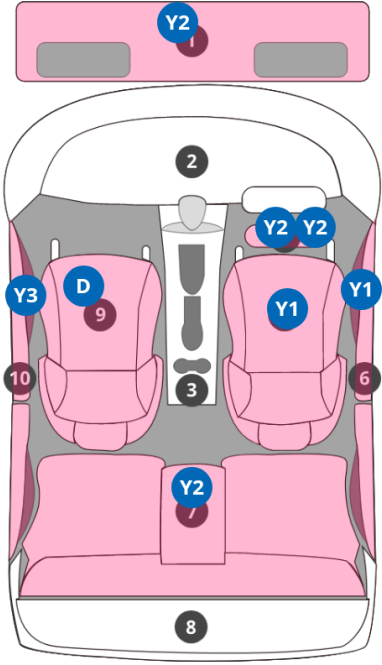
| Interior Evaluation : <b>B</b> | Exterior Evaluation : <b>D</b> |
| <b>Remarks</b><br>(R) Front Seat - Grime - Minimal / (L) Front Trim - Grime - Medium / (L) Front Seat - Worn - Yes / Rear Seat - Grime - Small / Ceiling - Grime - Small / (L) Front Floor Mat - Grime - Small / (R) Front Floor Mat - Grime - Small / (R) Front Trim - Grime - Minimal | <b>Remarks</b><br>(R) Front Door - Repair Traces - Yes / (R) Front Fender - Repair Traces - Yes / Bonnet - Repair Traces - Yes / (L) Front Fender - Repair Traces - Yes / (L) Front Door - Repair Traces - Yes / (L) Step - Repair Traces - Yes / (L) Rear Door - Repair Traces - Yes / (L) Rear Fender - Repair Traces - Yes / Trunk Hood, Rear Gate - Repair Traces - Yes / (R) Rear Fender - Repair Traces - Yes / (R) Rear Door - Repair Traces - Yes / Roof - Repair Traces - Yes / Trunk Hood, Rear Gate - Scratch & Dent - Minimal / Rear Bumper, Lamps, Panels - Scratch - Small / (L) Rear Fender, Molding - Repair mark - Yes / (L) Rear Fender, Molding - Scratch - Small / (L) Rear Door, Molding - Scratch - Small / (L) Rear Door, Molding - Repair mark - Yes / (L) Front Door, Molding - Repair mark - Yes / (L) Front Door, Molding - Scratch & Dent - Minimal / Roof - Scratch & Dent - Small / (L) Front Fender, Molding - Repair mark - Yes / (L) Front Fender, Molding - Scratch & Dent - Minimal / Front Bumper, Grille, Lamps - Repair mark - Yes / Bonnet, Headlight - Scratch & Dent - Minimal / Front Bumper, Grille, Lamps - Scratch - Small / (R) Front Fender, Molding - Scratch & Dent - Minimal / (R) Front Door, Molding - Scratch & Dent - Minimal / (R) Rear Door, Molding - Scratch & Dent - Small / (R) Step, In-panel, Side Spoiler - Scratch & Dent - Small / (R) Rear Fender, Molding - Scratch & Dent - Small / (L) Step, In-panel, Side Spoiler - Scratch & Dent - Small |
