## General Information

| Make | Toyota | Model | Vios |
| Registration No. | NIM9696 | Chassis No. | PA1B18F39P4210626 |

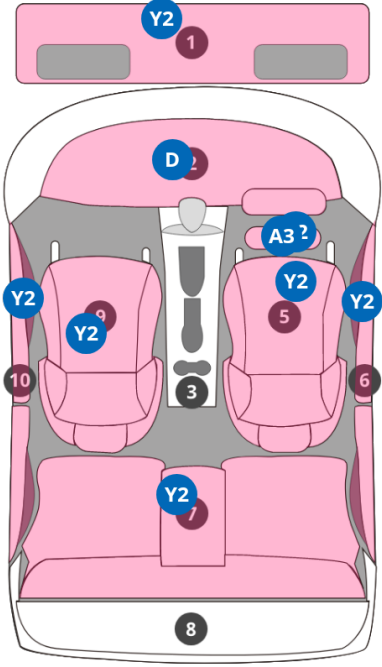
| Interior Evaluation : <b>B</b> | Exterior Evaluation : <b>E</b> |
| <p><b>Remarks</b></p> <p>(L) Front Floor Mat - Grime - Small / (R) Front Floor Mat - Cut, Crack - Medium / (L) Front Trim - Grime - Small / (R) Front Seat - Grime - Small / Rear Seat - Grime - Small / (L) Front Seat - Grime - Small / Ceiling - Grime - Small / (R) Front Trim - Grime - Small</p> | <p><b>Remarks</b></p> <p>(R) Front Fender - Repair Traces - Yes / Bonnet - Repair Traces - Yes / (L) Front Fender - Repair Traces - Yes / (L) Rear Door - Repair Traces - Yes / (L) Rear Fender - Repair Traces - Yes / Trunk Hood, Rear Gate - Repair Traces - Yes / Rear End Panel - Repair Traces - Yes / (R) Rear Door, Molding - Scratch &amp; Dent - Small / (R) Front Door, Molding - Scratch &amp; Dent - Small / (R) Step, In-panel, Side Spoiler - Scratch &amp; Dent - Medium / (R) Front Fender, Molding - Scratch &amp; Dent - Small / Bonnet, Headlight - Scratch &amp; Dent - Small / Front Bumper, Grille, Lamps - Scratch - Medium / (L) Front Fender, Molding - Scratch &amp; Dent - Small / (L) Front Door, Molding - Scratch &amp; Dent - Small / (L) Step, In-panel, Side Spoiler - Scratch &amp; Dent - Small / (L) Rear Door, Molding - Repair mark - Yes / (L) Rear Fender, Molding - Repair mark - Yes / (L) Rear Door, Molding - Scratch &amp; Dent - Small / (L) Rear Fender, Molding - Scratch &amp; Dent - Small / Roof - Scratch &amp; Dent - Small / Trunk Hood, Rear Gate - Scratch &amp; Dent - Small / Rear Bumper, Lamps, Panels - Scratch - Small / (R) Rear Fender, Molding - Scratch &amp; Dent - Small</p> |
