## General Information

| Make | Toyota | Model | Wigo |
| Registration No. | GAV2552 | Chassis No. | MHKA4DE5FMJ016331 |

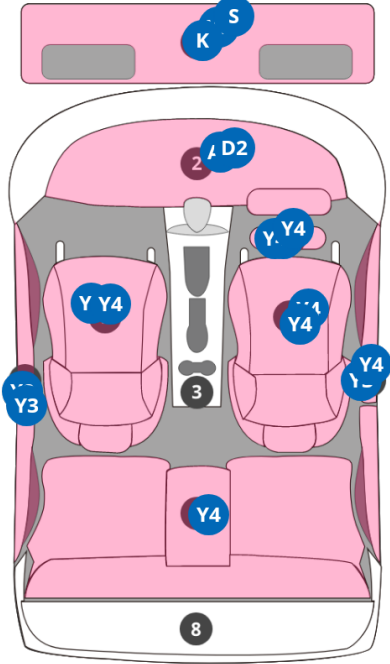
| Interior Evaluation : | E | Exterior Evaluation : | N / A |
|---|---|---|---|
| <p>a : Cut, Fray d : Loose, Deformed k : Animal Hair s : Smell t : Cigarette Burns x : Defective y : Stain</p> | | | |
| <b>Remarks</b><br>(L) Front Trim - Grime - Small / Steering Wheel - Worn, Peel, Crack - Large / Ceiling - Grime - Medium / (L) Front Seat - Grime - Medium / (L) Front Floor Mat - Grime - Medium / (L) Rear Trim - Grime - Medium / Rear Seat - Grime - Large / Mat Other - Grime - Large / (R) Rear Trim - Grime - Medium / (R) Front Trim - Grime - Large / (R) Front Floor Mat - Grime - Large / Glove Box - Loose, Deformed - Small / (R) Front Seat - Grime - Large / (R) Front Seat belt - Grime - Large / Overall Interior - Animal Hair - Yes / Overall Interior - Smell - Yes / (L) Front Seat belt - Grime - Large | | <b>Remarks</b><br>Defects not found | |
