## General Information

| Make | Toyota | Model | Hiace |
| Registration No. | NIP4601 | Chassis No. | JTFJT02P4P5034887 |

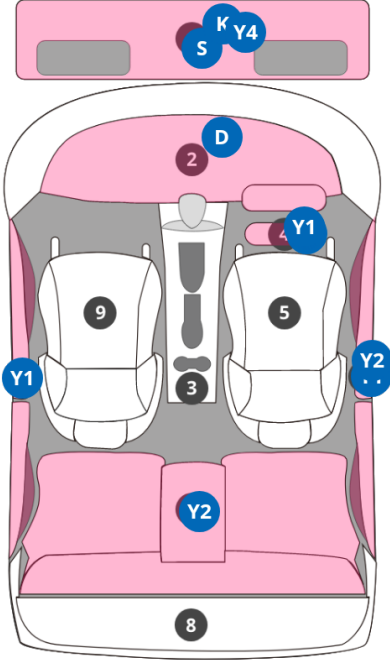
| Interior Evaluation : <b>C</b> | Exterior Evaluation : <b>D</b> |
| <p><b>Remarks</b></p> <p>Overall Interior - Smell - Yes / Overall Interior - Animal Hair - Yes / Ceiling - Grime - Large / (L) Front Floor Mat - Grime - Small / (R) Front Trim - Grime - Minimal / (L) Front Trim - Grime - Minimal / (R) Rear Trim - Grime - Small / Rear Seat - Grime - Small / Mat Other - Grime - Small / (R) Front Floor Mat - Grime - Minimal / Dashboard - Traces of Adhesive Tape - Yes</p> | <p><b>Remarks</b></p> <p>Front Bumper, Grille, Lamps - Scratch - Minimal / Bonnet, Headlight - Scratch - Minimal / (R) Mirror - Scratch - Small / (R) Front Door, Molding - Scratch - Small / (R) Front Fender, Molding - Scratch - Minimal / (R) Center Panel - Scratch - Minimal / (R) Step, In-panel, Side Spoiler - Scratch - Medium / (R) Rear Door, Molding - Scratch - Medium / (R) Rear Fender, Molding - Scratch - Small / Rear Bumper, Lamps, Panels - Scratch &amp; Dent - Small / (L) Rear Fender, Molding - Scratch - Small / (L) Front Door, Molding - Scratch - Small / (L) Mirror - Scratch - Minimal / Trunk Hood, Rear Gate - Scratch &amp; Dent - Large / (L) Step, In-panel, Side Spoiler - Scratch - Medium</p> |

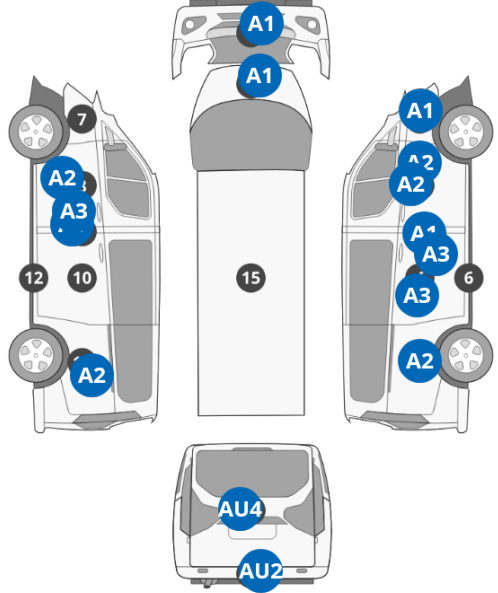
| Inspector Notes |
|---|
| <p>Paint marks at exterior. Incomplete tools. Without warranty booklet. With sparetire, seatcover, jack, LTO PLate and 1key.</p> |
