## General Information

| Make | Suzuki | Model | Carry |
| Registration No. | GAP2742 | Chassis No. | MHYHDC61TMJ916398 |

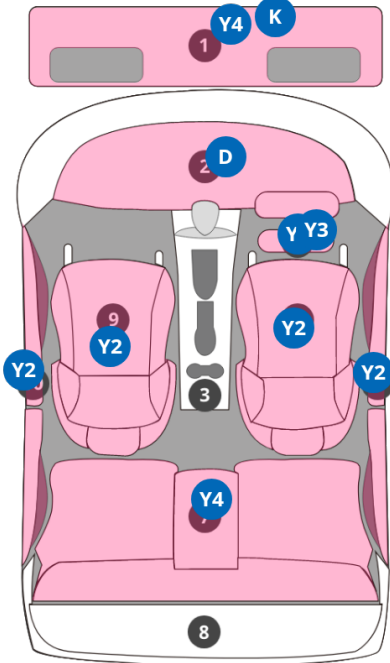
| Interior Evaluation : <span style="color: red;">C</span> | Exterior Evaluation : <span style="color: red;">E</span> |
| <p><b>Remarks</b><br/>Ceiling - Grime - Large / Rear Seat - Grime - Large / (R) Front Trim - Grime - Small / (R) Front Seat - Grime - Small / (R) Front Floor Mat - Grime - Medium / (L) Front Floor Mat - Grime - Medium / Dashboard - Traces of Adhesive Tape - Yes / (L) Front Trim - Grime - Small / (L) Front Seat - Grime - Small / Overall Interior - Animal Hair - Yes</p> | <p><b>Remarks</b><br/>Bonnet - Repair Traces - Yes / (L) Front Fender - Repair Traces - Yes / (L) Center Panel - Scratch &amp; Dent - Medium / (L) Step, In-panel, Side Spoiler - Rust, Corrosion - Medium / (L) Front Door, Molding - Scratch - Medium / (L) Front Fender, Molding - Scratch - Minimal / Front Bumper, Grille, Lamps - Scratch - Large / Bonnet, Headlight - Scratch - Minimal / (R) Front Fender, Molding - Scratch &amp; Dent - Medium / (R) Front Door, Molding - Scratch &amp; Dent - Large / (R) Step, In-panel, Side Spoiler - Scratch - Small / (R) Center Panel - Scratch - Small / (R) Side Gate - Scratch - Large / Rear Bumper, Lamps, Panels - Scratch - Medium / Rear Gate - Scratch - Large / (L) Side Gate - Scratch - Large</p> |
