## General Information

| Make | Toyota | Model | Raize |
| Registration No. | NIQ2461 | Chassis No. | MHKAB1BA8PJ061486 |

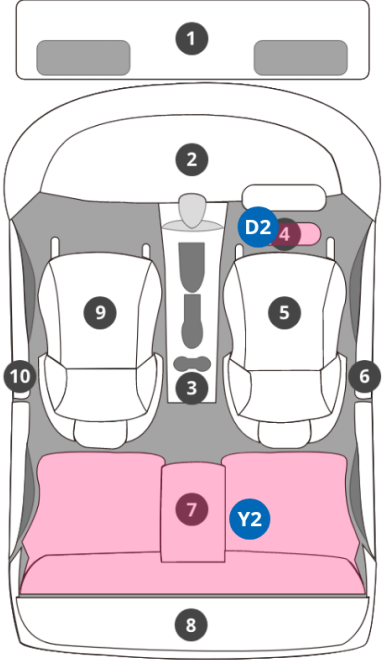
| Interior Evaluation : <span style="color: red;">A</span> | Exterior Evaluation : <span style="color: red;">C</span> |
| <b>Remarks</b><br>Rear Seat - Grime - Small / (L) Front Floor Mat - Worked - Small | <b>Remarks</b><br>Member (Bolted) - Dent - Yes / (L) Front Door, Molding - Scratch & Dent - Large / Front Bumper, Grille, Lamps - Scratch & Dent - Large / (R) Rear Door, Molding - Scratch - Small / (L) Mirror - Scratch - Small / (R) Front Fender, Molding - Dent - Small / (R) Front Door, Molding - Scratch - Small / Rear Bumper, Lamps, Panels - Scratch & Dent - Medium / (L) Rear Fender, Molding - Scratch & Dent - Small / Roof - Dent - Minimal |

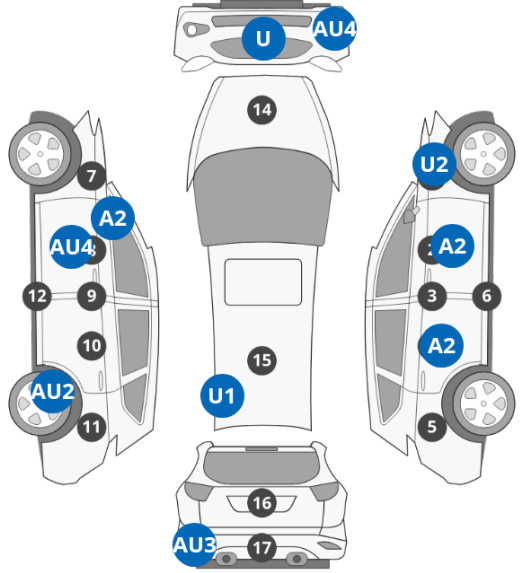
| Inspector Notes |
|---|
| without warranty booklet. with Spare tire and jack but incomplete tools. with LTO plate. Gap at the right front bumper and at the left rear bumper. |
