## General Information

| Make | Toyota | Model | Lite Ace |
| Registration No. | FAN9186 | Chassis No. | MHKU3FE10NK001398 |

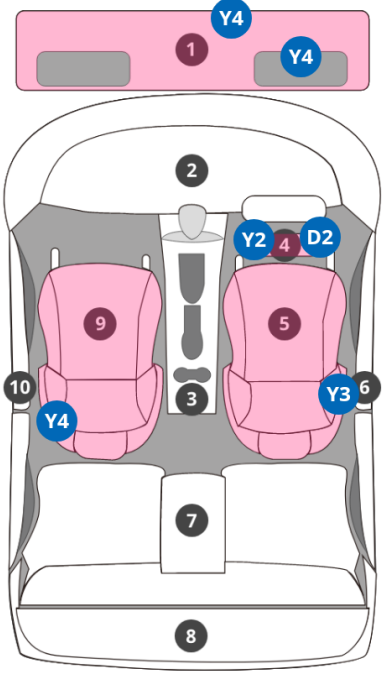
| Interior Evaluation : <b>C</b> | Exterior Evaluation : <b>E</b> |
| <b>Remarks</b><br>Ceiling - Grime - Large / Sunvisor, Sunglass Holder - Grime - Large / (L) Front Seat - Grime - Large / (R) Front Seat - Grime - Medium / Carpet - Loose, Deformed - Small / (R) Front Floor Mat - Grime - Small | <b>Remarks</b><br>(R) Front Door - Repair Traces - Yes / (L) Step - Repair Traces - Yes / (L) Step, In-panel, Side Spoiler - Rust, Corrosion - Medium / (L) Step, In-panel, Side Spoiler - Repair mark - Yes / (L) Center Panel - Repair mark - Yes / (L) Front Door, Molding - Scratch & Dent - Small / (L) Center Panel - Scratch - Small / (L) Side Gate - Repair mark - Yes / (L) Side Gate - Rust, Corrosion - Large / Rear Bumper, Lamps, Panels - Modified - Medium / Rear Gate - Partially Missing - Yes / Cargo Bed Floor - Rust, Corrosion - Large / (R) Side Gate - Repair mark - Yes / (R) Side Gate - Rust, Corrosion - Large / (R) Front Door, Molding - Scratch & Dent - Large / (R) Front Door, Molding - Repair mark - Yes / (L) Front Fender, Molding - Scratch - Small / (R) Front Fender, Molding - Scratch - Small / Front Panel - Rust, Corrosion - Small / Front Bumper, Grille, Lamps - Scratch - Medium / Roof - Scratch - Small / (R) Step, In-panel, Side Spoiler - Rust, Corrosion - Small / (R) Center Panel - Repair mark - Yes / (R) Center Panel - Scratch & Dent - Small / Cab Back Panel - Scratch - Small / Rear Bumper, Lamps, Panels - Scratch - Small |
