## General Information

| Make | Toyota | Model | Hiace |
| Registration No. | NHI7565 | Chassis No. | JTFJT02P8P0016826 |

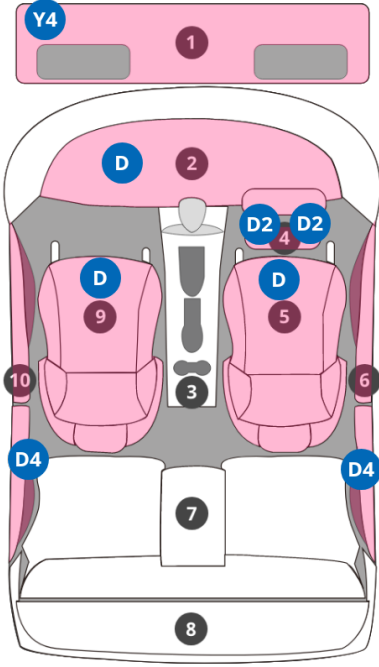
| Interior Evaluation : <b>D</b> | Exterior Evaluation : <b>C</b> |
| <p><b>Remarks</b></p> <p>Ceiling - Grime - Large / Overall Interior - Worn as per age - Yes / Dashboard - Traces of Adhesive Tape - Yes / (L) Rear Trim - Worked - Large / (R) Rear Trim - Worked - Large / (L) Front Seat - Worn - Yes / (R) Front Seat - Worn - Yes / (L) Front Floor Mat - Worked - Small / (R) Front Floor Mat - Worked - Small</p> | <p><b>Remarks</b></p> <p>(R) Front Door, Molding - Scratch - Small / (R) Front Fender, Molding - Scratch - Minimal / (R) Rear Door, Molding - Scratch &amp; Dent - Medium / (R) Rear Fender, Molding - Scratch - Minimal / Trunk Hood, Rear Gate - Scratch &amp; Dent - Large / (L) Rear Door, Molding - Scratch &amp; Dent - Small / (L) Front Door, Molding - Scratch - Small / (L) Mirror - Scratch - Minimal / Front Bumper, Grille, Lamps - Scratch - Small / Front Panel - Scratch - Minimal / Overall Exterior - Faded(Color, Gloss) - Yes / Roof - Scratch - Minimal</p> |
