## General Information

| Make | Suzuki | Model | Carry |
| Registration No. | KAF7436 | Chassis No. | MHYHDC61TMJ916421 |

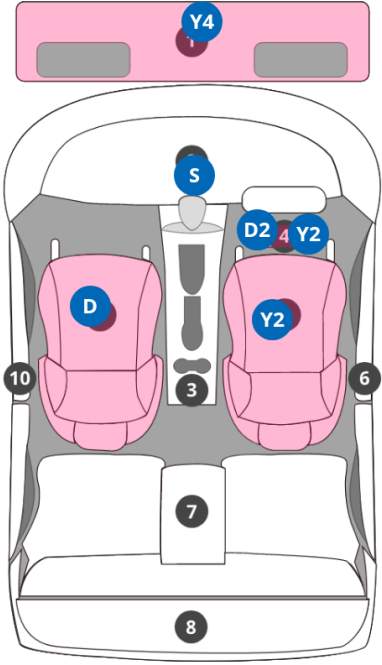
| Interior Evaluation : <span style="color: red;">C</span> | Exterior Evaluation : <span style="color: red;">E</span> |
|---|---|
| <b>Remarks</b><br>Ceiling - Grime - Large / (R) Front Floor Mat - Grime - Small / (L) Front Floor Mat - Worked - Small / (R) Front Seat - Grime - Small / (L) Front Seat - Worn - Yes / Overall Interior - Smell - Yes | <b>Remarks</b><br>Rear Gate - Modified - Medium / Cargo Bed Floor - Rust, Corrosion - Large / Rear Bumper, Lamps, Panels - Rust, Corrosion - Large / (L) Side Gate - Scratch - Large / (L) Center Panel - Scratch - Small / (L) Front Door, Molding - Scratch & Dent - Medium / (L) Mirror - Scratch - Small / (L) Front Fender, Molding - Scratch - Minimal / Front Panel - Scratch - Small / (R) Front Fender, Molding - Scratch - Minimal / Front Bumper, Grille, Lamps - Scratch - Large / (R) Step, In-panel, Side Spoiler - Scratch - Small / (L) Step, In-panel, Side Spoiler - Scratch - Small / (R) Front Door, Molding - Scratch & Dent - Medium / (R) Side Gate - Scratch & Dent - Large / Rear Gate - Scratch - Small / Roof - Scratch - Small / (R) Mirror - Scratch - Small |
