## General Information

| Make | Toyota | Model | Fortuner |
| Registration No. | NFI8013 | Chassis No. | MHFAA3GS0M0741592 |

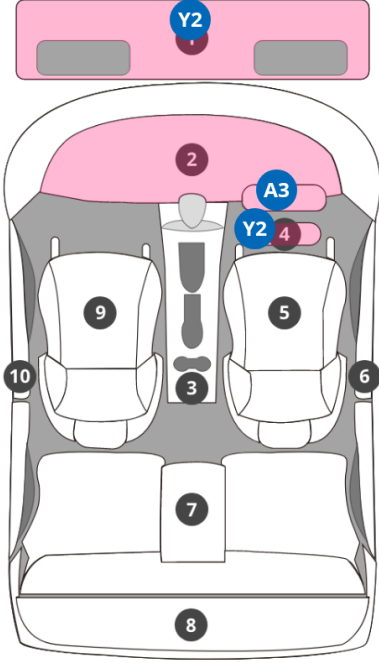
| Interior Evaluation : <b>B</b> | Exterior Evaluation : <b>C</b> |
|---|---|
| <p><b>Remarks</b><br/>Ceiling - Grime - Small / (L) Front Floor Mat - Grime - Small / Steering Wheel - Worn, Peel, Crack - Medium</p> | <p><b>Remarks</b><br/>(R) Mirror - Scratch - Small / (L) Rear Door, Molding - Dent - Small / (R) Rear Fender, Molding - Dent - Small / (R) Rear Door, Molding - Dent - Small / Front Bumper, Grille, Lamps - Scratch - Small / Rear Bumper, Lamps, Panels - Scratch - Large / Roof - Scratch - Small</p> |
