## General Information

| Make | Nissan | Model | NV350 |
| Registration No. | NFW7860 | Chassis No. | JN1TC2EZ6Z0059671 |

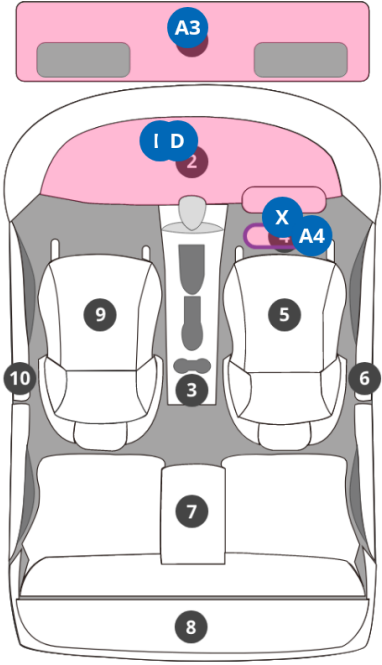
| Interior Evaluation : <b>C</b> | Exterior Evaluation : <b>E</b> |
| <b>Remarks</b><br>Overall Interior - Worn as per age - Yes / Overall Interior - Animal Hair - Yes / Mat Other - Missing - Yes / (R) Front Floor Mat - Cut, Crack - Large / Ceiling - Cut, Crack - Medium / Dashboard - Traces of Adhesive Tape - Yes | <b>Remarks</b><br>(R) Front Door - Repair Traces - Yes / (R) Step - Repair Traces - Yes / (R) Rear Fender - Repair Traces - Yes / Rear Bumper, Lamps, Panels - Scratch & Dent - Large / (R) Rear Fender, Molding - Scratch & Dent - Large / (R) Rear Door, Molding - Scratch & Dent - Large / (R) Center Panel - Scratch - Medium / Front Bumper, Grille, Lamps - Scratch & Dent - Large / (R) Front Door, Molding - Scratch - Small / (L) Front Door, Molding - Scratch & Dent - Small / Front Panel - Scratch & Dent - Small / (L) Rear Fender, Molding - Scratch & Dent - Large / Trunk Hood, Rear Gate - Dent - Medium |
