## General Information

| Make | Mitsubishi | Model | Adventure |
| YOM | 2017 | Odo Meter Reading | 106,332 |
| Registration No. | NCA8446 | Chassis No. | PAEVB5NHHHB019717 |

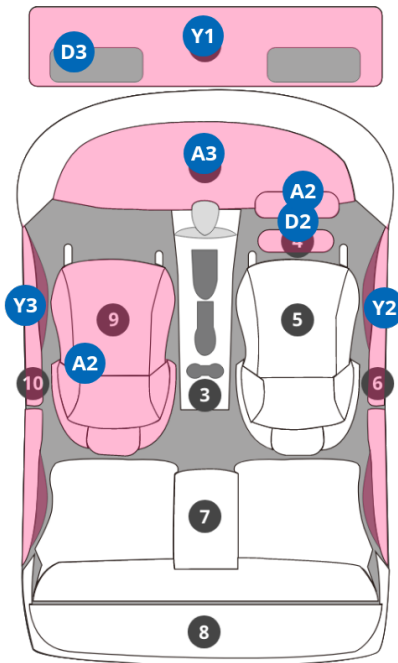
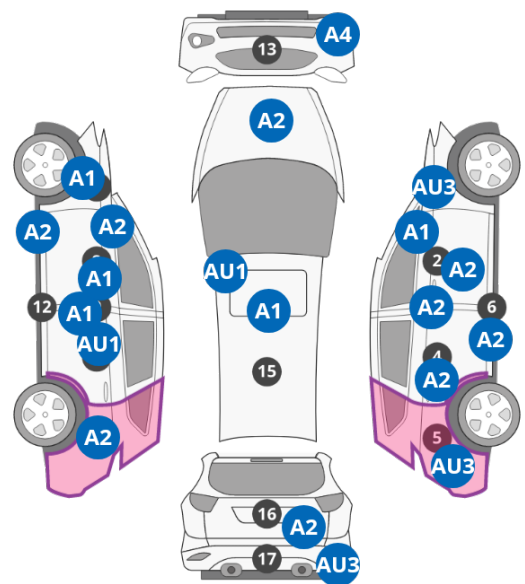
| Interior Evaluation : <span style="color: red;">C</span> | Exterior Evaluation : <span style="color: red;">E</span> |
|---|---|
| <p><b>Remarks</b></p> <p>(R) Front Trim - Grime - Small / Sunvisor, Sunglass Holder - Loose, Deformed - Medium / Steering Wheel - Worn, Peel, Crack - Medium / (L) Front Trim - Grime - Medium / (L) Front Floor Mat - Worked - Small / (L) Front Seat - Cut, Crack - Small / Ceiling - Grime - Minimal / Glove Box - Worn, Scratch, Cut, Crack - Small</p> | <p><b>Remarks</b></p> <p>(L) Rear Fender - Repair Traces - Yes / Trunk Hood, Rear Gate - Repair Traces - Yes / (R) Rear Fender - Repair Traces - Yes / Overall Exterior - Worn as per age - Yes / (R) Front Fender, Molding - Scratch &amp; Dent - Medium / (R) Mirror - Scratch - Minimal / (R) Front Door, Molding - Scratch - Small / (R) Step, In-panel, Side Spoiler - Scratch - Small / (R) Rear Door, Molding - Scratch - Small / (R) Rear Fender, Molding - Repair mark - Difference in Color / (R) Rear Fender, Molding - Scratch &amp; Dent - Medium / Rear Bumper, Lamps, Panels - Scratch &amp; Dent - Medium / Trunk Hood, Rear Gate - Scratch - Small / (L) Rear Fender, Molding - Repair mark - Difference in Color / (L) Rear Fender, Molding - Scratch - Small / (L) Rear Door, Molding - Scratch &amp; Dent - Minimal / (R) Center Panel - Scratch - Small / (L) Center Panel - Scratch - Minimal / (L) Front Door, Molding - Scratch - Minimal / (L) Mirror - Scratch - Small / (L) Step, In-panel, Side Spoiler - Scratch - Small / (L) Front Fender, Molding - Scratch - Minimal / Front Bumper, Grille, Lamps - Scratch - Large / Bonnet, Headlight - Scratch - Small / Roof - Scratch - Minimal / Roof Spoiler, Molding - Scratch &amp; Dent - Minimal</p> |
