## General Information

| Make | Toyota | Model | Avanza |
| Registration No. | EAE3550 | Chassis No. | MHKM5EF2FMK028286 |

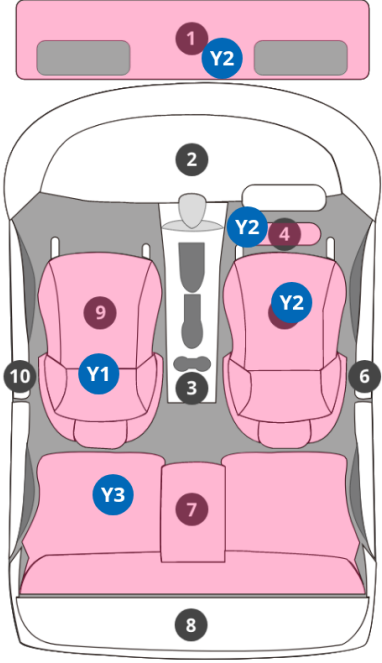
| Interior Evaluation : <b>B</b> | Exterior Evaluation : <b>B</b> |
| <p><b>Remarks</b></p> <p>(R) Front Seat - Grime - Small / Ceiling - Grime - Small / Rear Seat - Grime - Medium / (L) Front Seat - Grime - Minimal / (L) Front Floor Mat - Grime - Small</p> | <p><b>Remarks</b></p> <p>(R) Front Fender - Repair Traces - Yes / Bonnet - Repair Traces - Yes / (L) Front Fender - Repair Traces - Yes / (R) Rear Fender - Repair Traces - Yes / (R) Rear Door - Repair Traces - Yes / (L) Rear Fender, Molding - Dent - Medium / Trunk Hood, Rear Gate - Dent - Medium / (R) Step, In-panel, Side Spoiler - Dent - Medium / (R) Front Door, Molding - Dent - Small / Rear Bumper, Lamps, Panels - Crack, Gap - Small</p> |

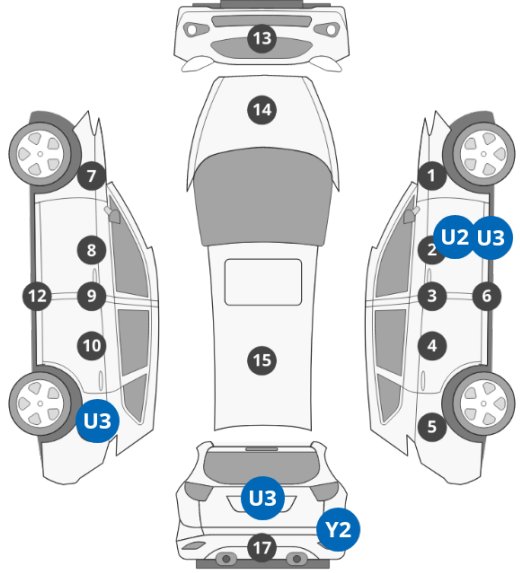
| Inspector Notes |
|---|
| with spare tire. without warranty booklet, tools and jack. with LTO plate. crack right tail light. |
